# **The Marlie Farm Explosion**

**Significant Findings of the Investigation into the  
Fire and Fatal Explosion  
Festival Fireworks Ltd, Marlie Farm, Ringmer, East Sussex, U.K.  
Sunday 3 December 2006**

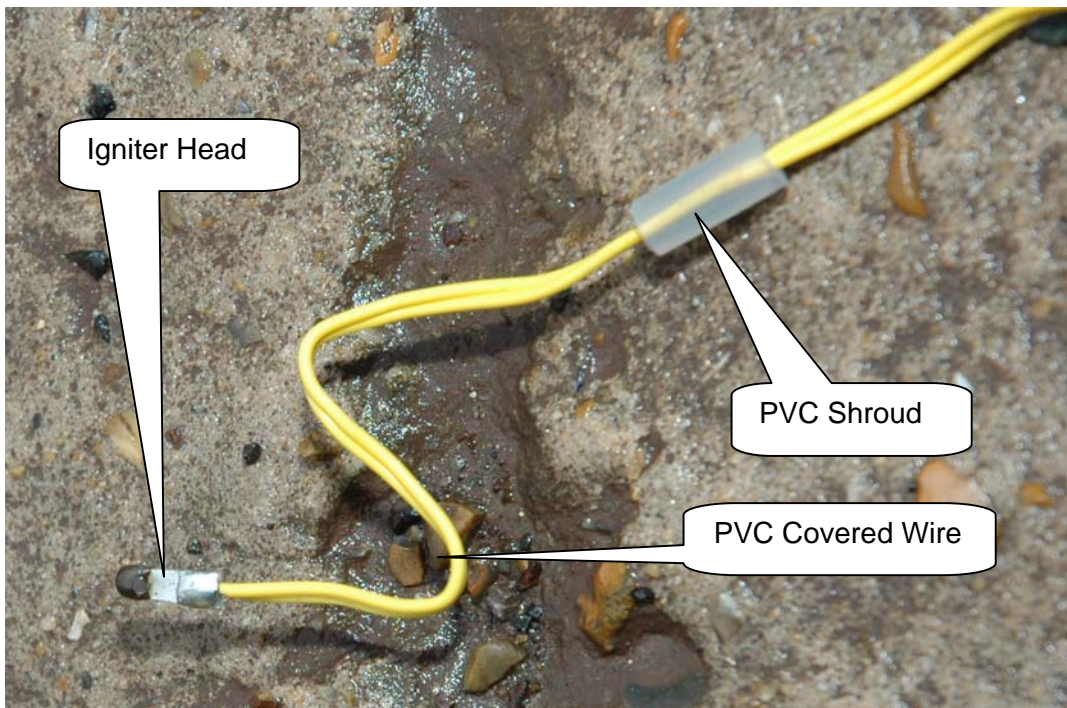
Examination of the Marlie farm site post explosion revealed a number of different types of electric igniters some of which were sheathed, and some were not.

Example of Igniter found on Site (Copyright Sussex Police)

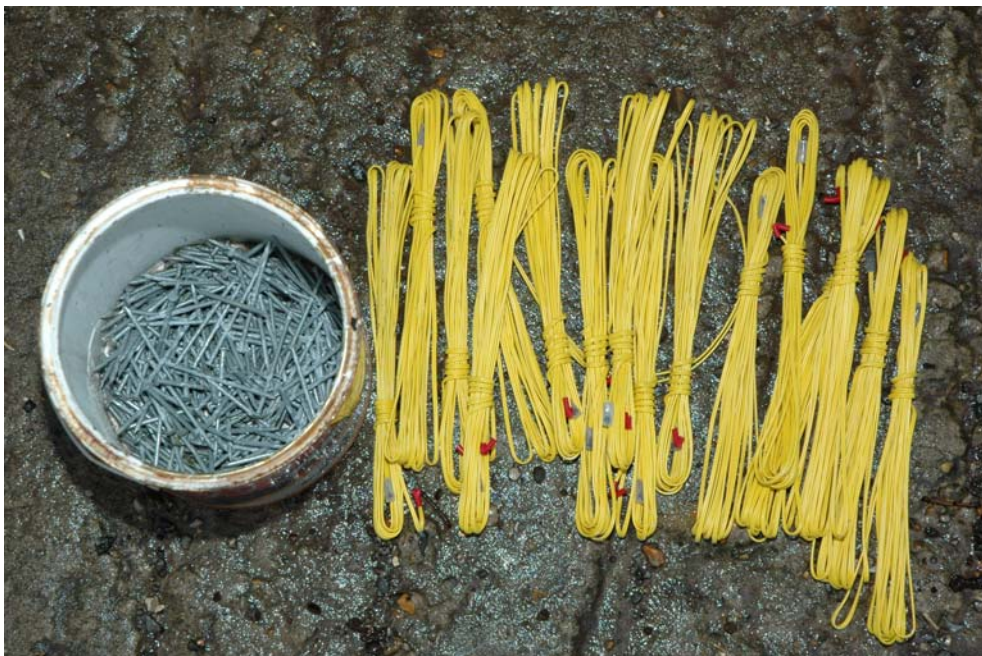
In addition loose igniters were found on the blue lorry, in metal paint cans mixed with nails. This is extremely hazardous as it can lead to damage to the protective lacquer, which then makes the Igniter more susceptible to accidental ignition through friction.

Electric Igniters and contents of paint tin on Blue Lorry (Copyright Sussex Police)

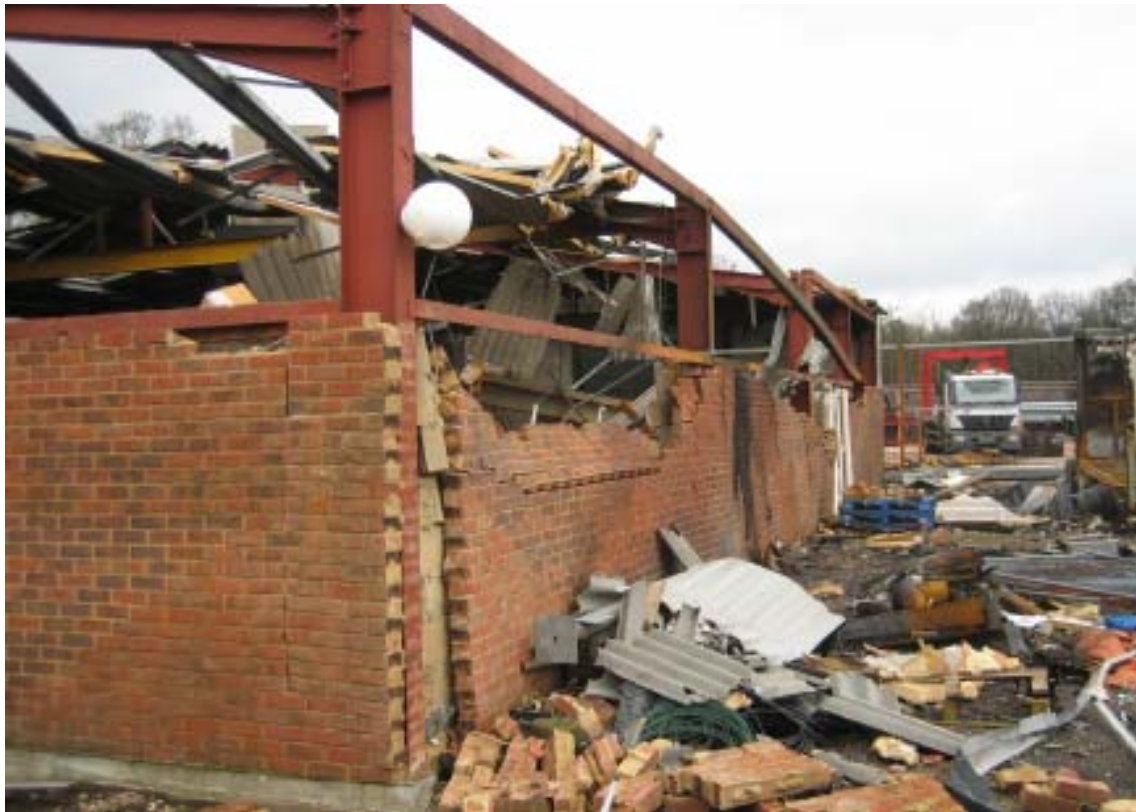
As a result of the detonation, the ISO container fragmented and a shock wave was generated, which damaged buildings and vehicles within the vicinity of the site.

Damage on site to Builders Beams 2 building

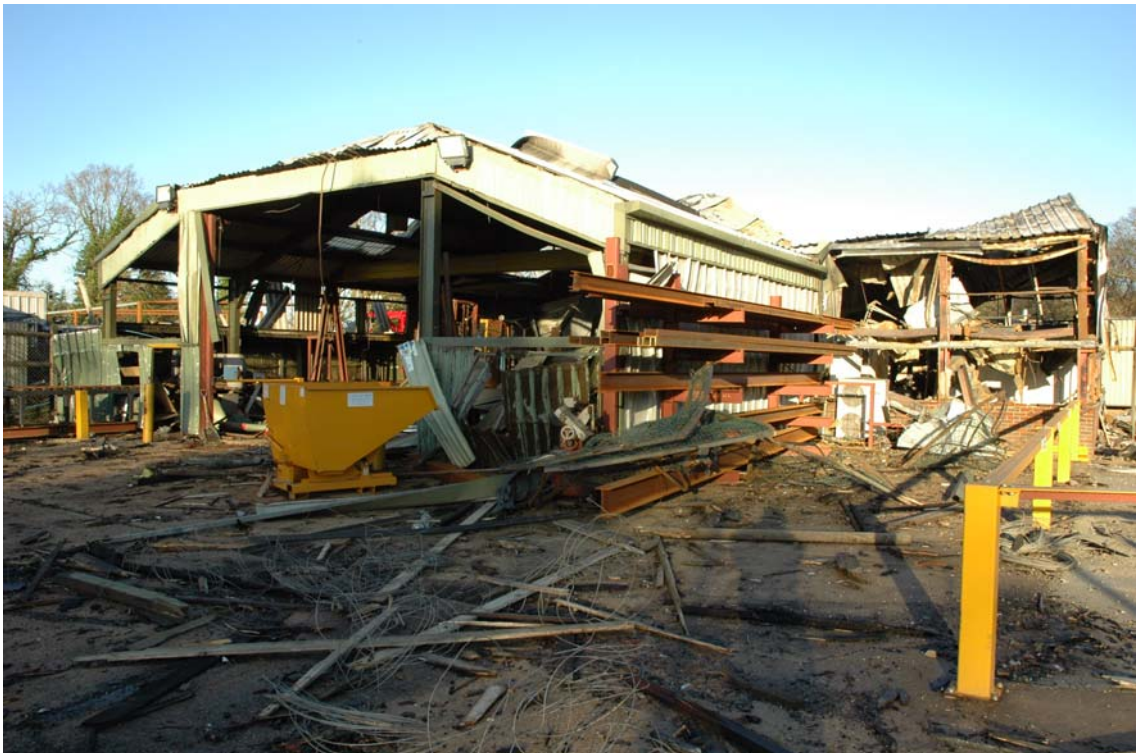
Damage on site to Builders Beams 1 building

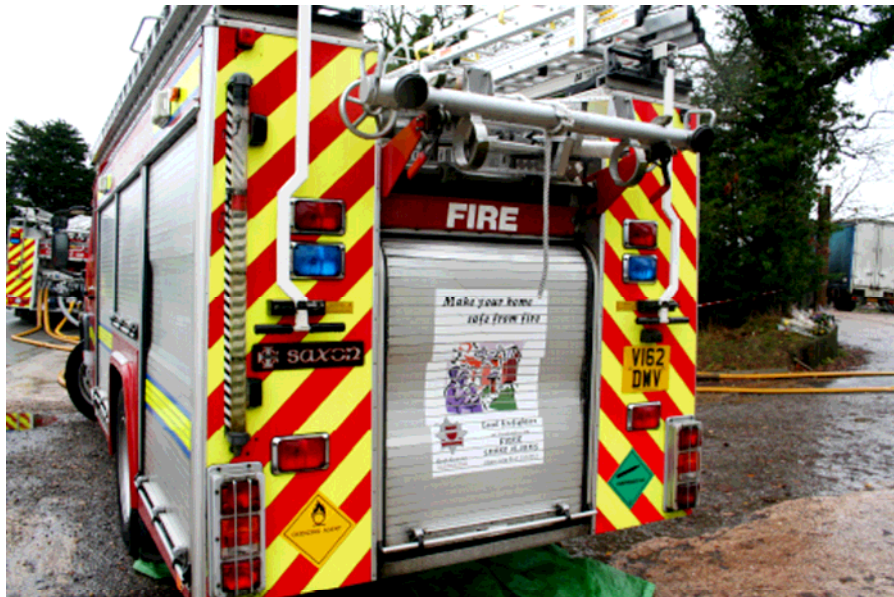
The shockwave caused damage to vehicles on the road and to buildings away from the site.

Damage to fire appliances

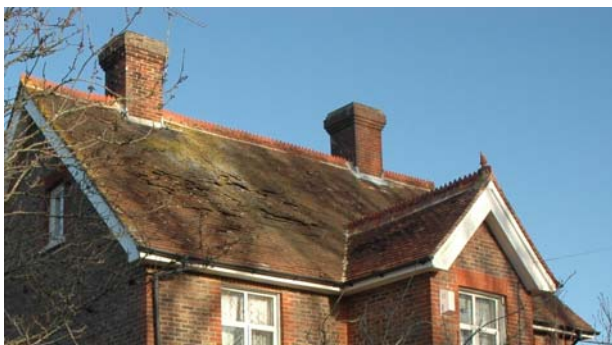
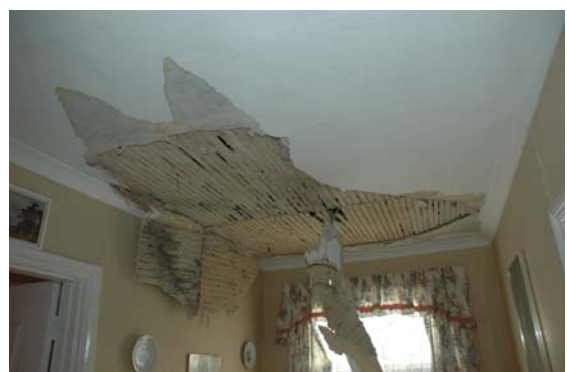
House 120 metres away from container

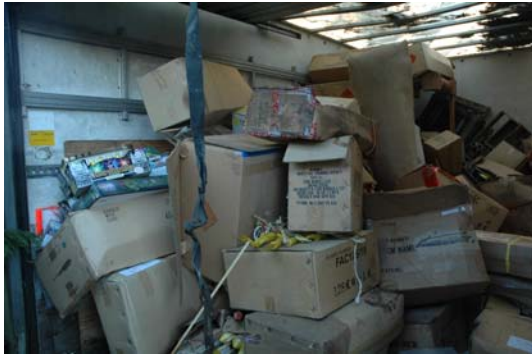
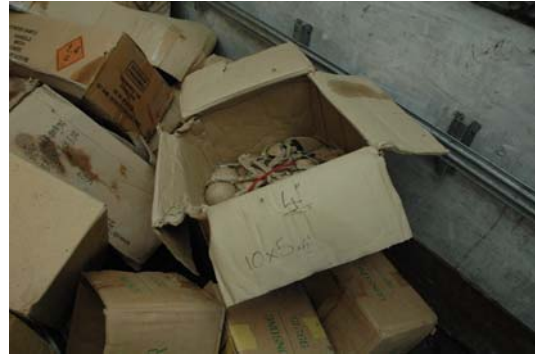
The white container appeared to be the body from a lorry located next to magazine E and not forming part of the HSE Licence. Inside were found numerous fireworks including: three 200 mm shells, one ground maroon containing 290 g of flash powder, one 100 mm mine, one titanium maroon and two boxes of 125 mm shells with lift charges removed.

Boxes of fireworks found in white container post explosion

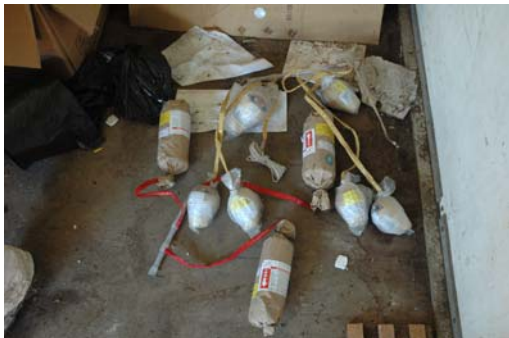
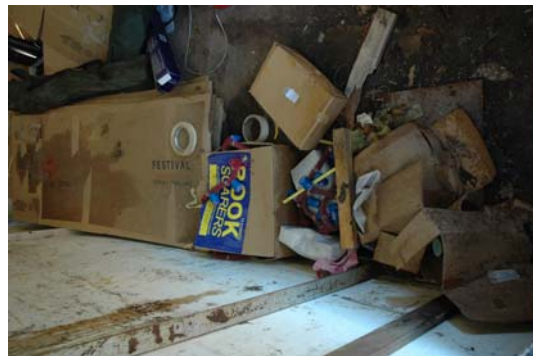
This was a trailer located near to magazine E and not forming part of the HSE Licence. A mixture of boxes and fireworks, some loose, some packed, including: chained 3 inch shells, one 75mm report shell, one Galaxy salute and bird scarers, were found inside the trailer.

Fireworks found in red container post explosion

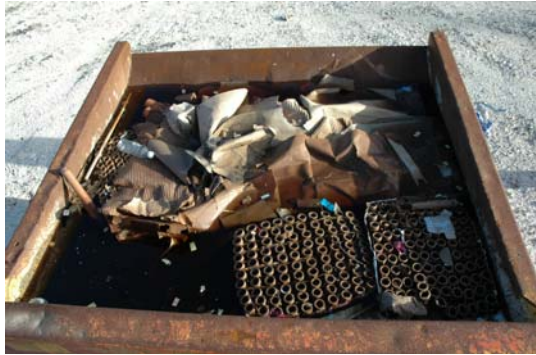
A number of cakes, various calibre roman candles and fountains were found in the front bucket of the dumper truck. A number of these were complete with fuses, indicating that they were not spent cases. At the time of the investigation the front bucket was full of water. It is not known if this was being used as some form of soak tank, for movement of fireworks prior to the incident or for storage.

Bucket of dumper truck filled with fireworks post explosion

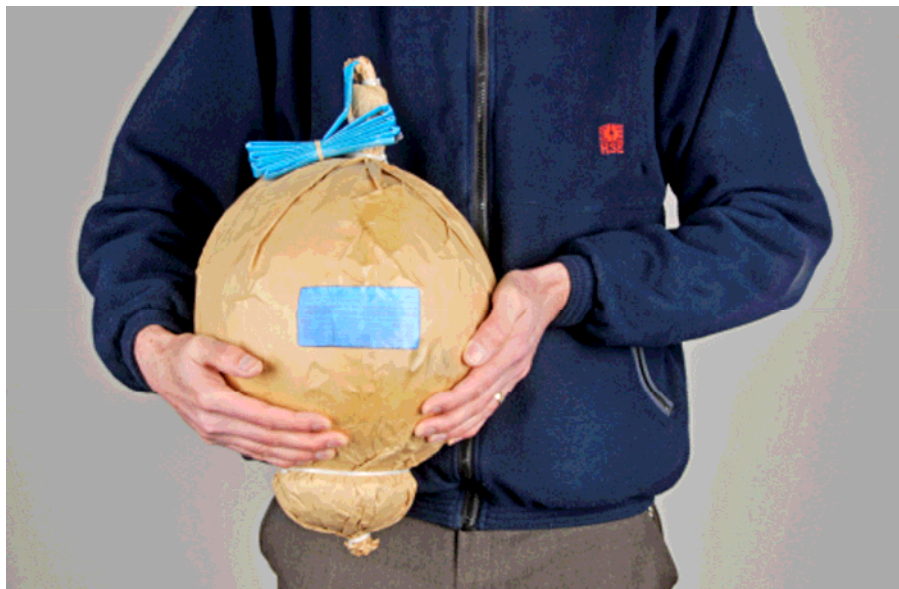
Mock up of 300mm shell found in magazine E post explosion (photo from HSE)

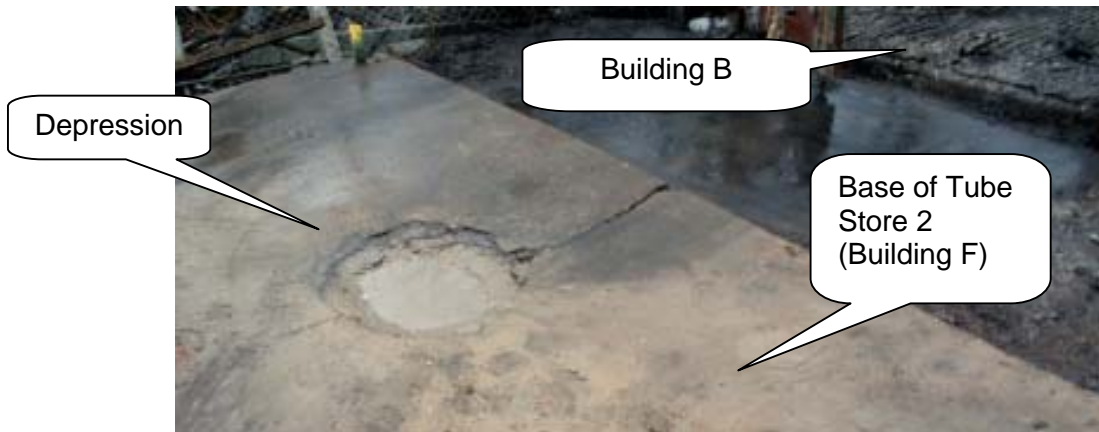
and they also showed signs of a high velocity object penetrating through the walls, known as “petalling”, which occurs from projectiles from an explosion. In addition a large depression was found in the concrete base, approximately 750 mm in diameter and 150 mm deep. The expert evidence present during the recent court case indicated that: *'This is consistent with a substantial explosion occurring in this area.'*

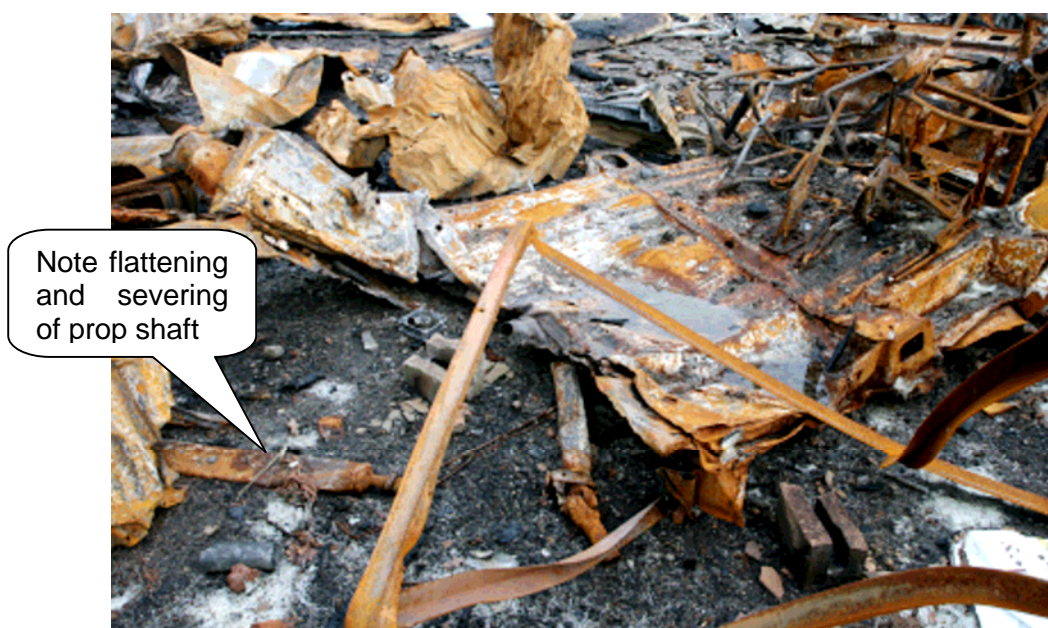
The Transit Van was being loaded with fireworks ready for a display later that afternoon when the fire occurred. The damage to the van, including severing and flattening of the prop shaft is consistent with the activation of high-energy fireworks.

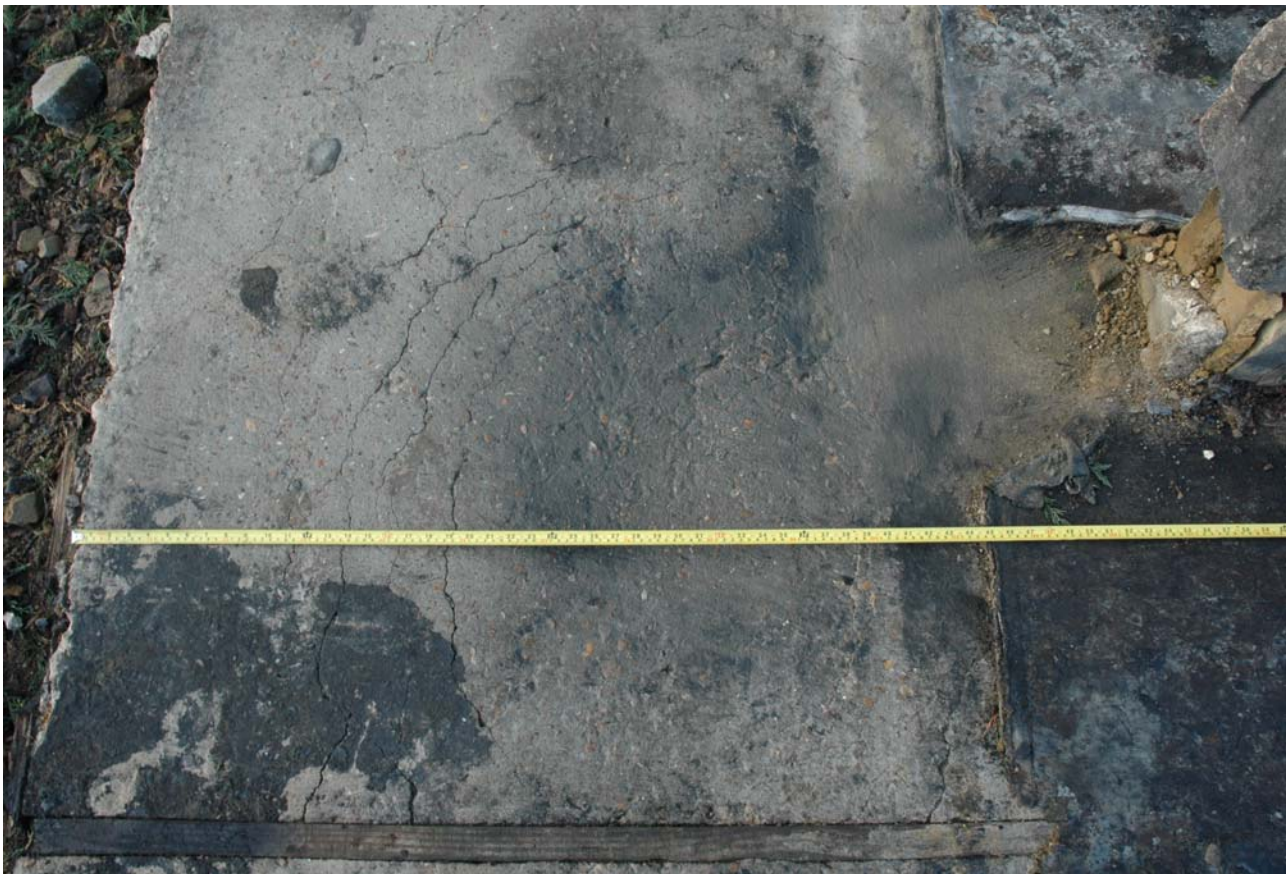
Image showing depression and cracking in concrete walkway.

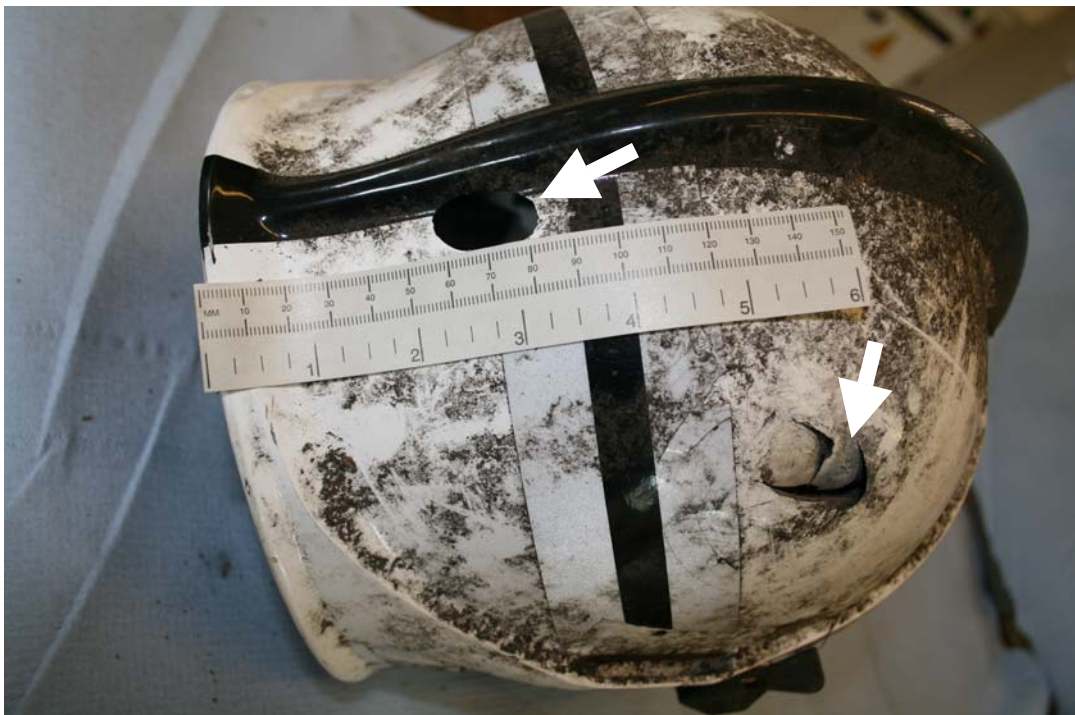
Firework impact damage to helmet

- Issues amended instructions to wearers to reflect the models of Gallet F1 helmet now in use within SEPPEC and the respective methods for securing chinstraps.
- Ensures that MSA Gallet/Cosalt carry out an audit on all Gallet helmets within SEPPEC to verify the correct fitting of inner comfort pads and stopper buckles, as necessary.
- Ensures that all relevant personnel have been issued with a helmet bag and instructed to store their helmet in this when not in use.

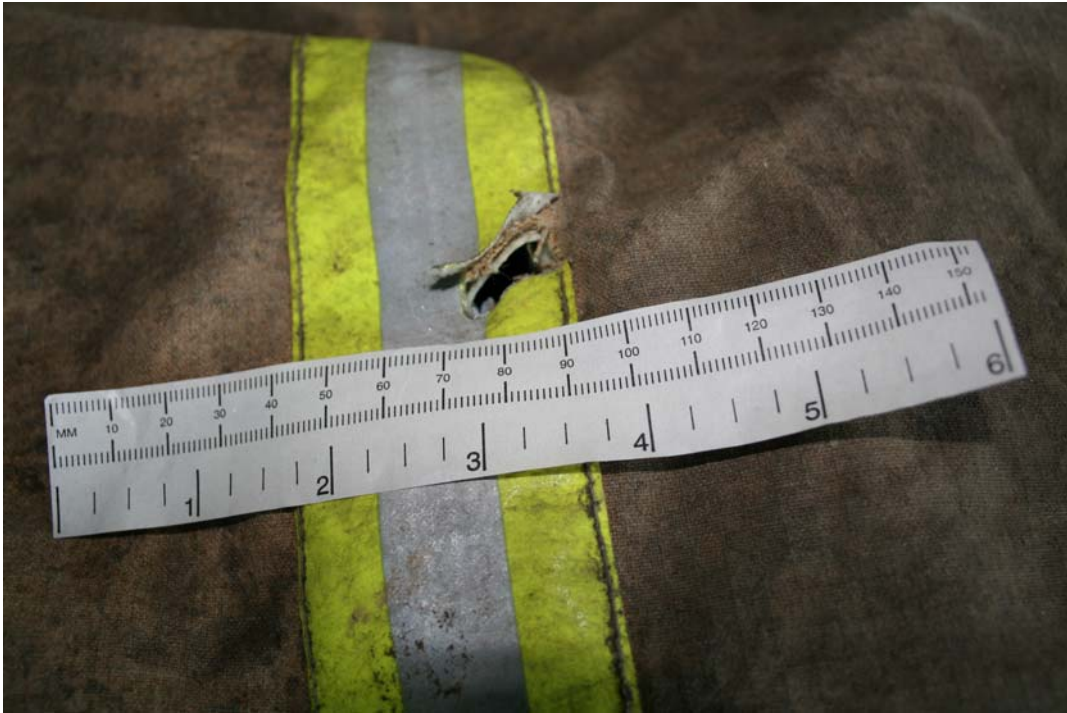
Penetration site of right leg of over-trousers

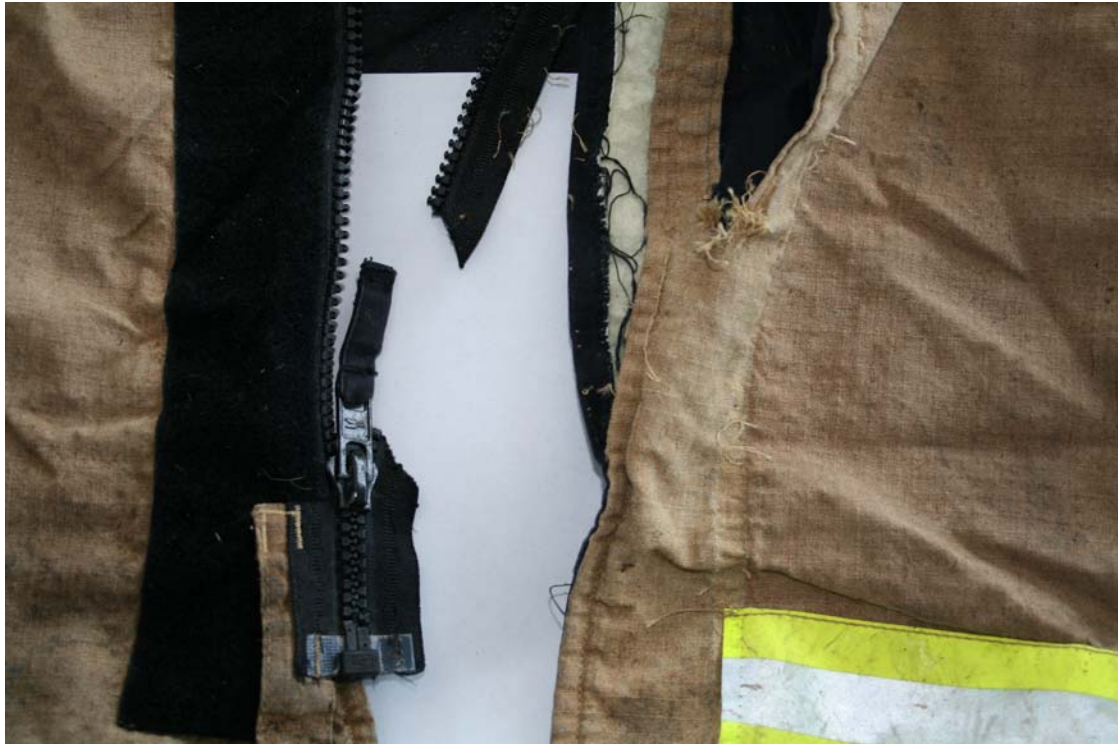
Damage to Tunic, note damage to Zip and total loss of covering flap
