# **The Marlie Farm Explosion**

**Significant Findings of the Investigation into the  
Fire and Fatal Explosion  
Festival Fireworks Ltd, Marlie Farm, Ringmer, East Sussex, U.K.  
Sunday 3 December 2006**

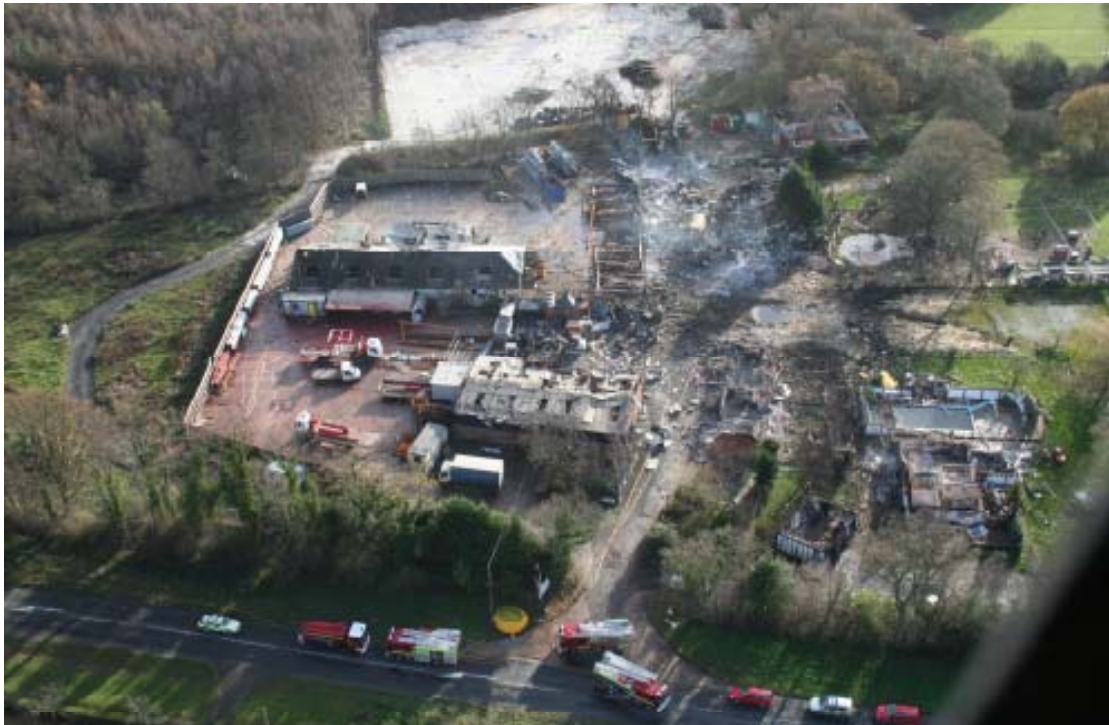
Photo of accident site on the following morning

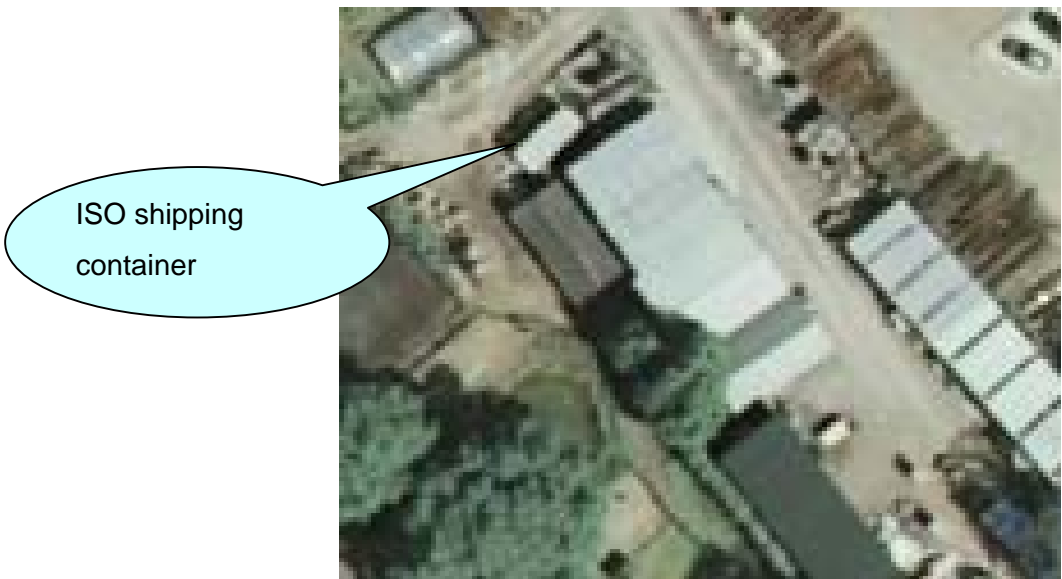
Photo showing location of ISO container

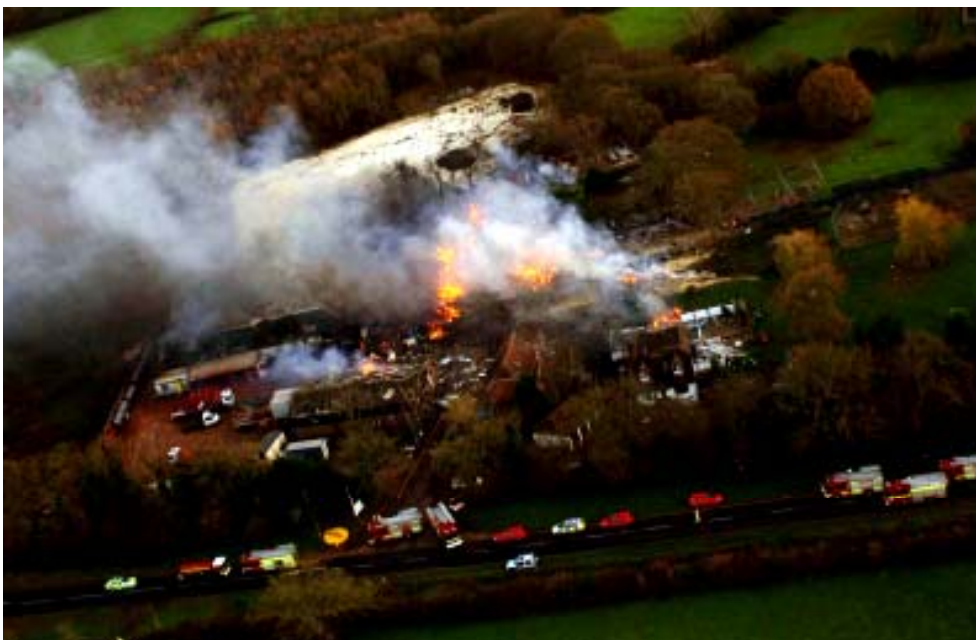
Photograph taken by police helicopter approximately half an hour after the explosion

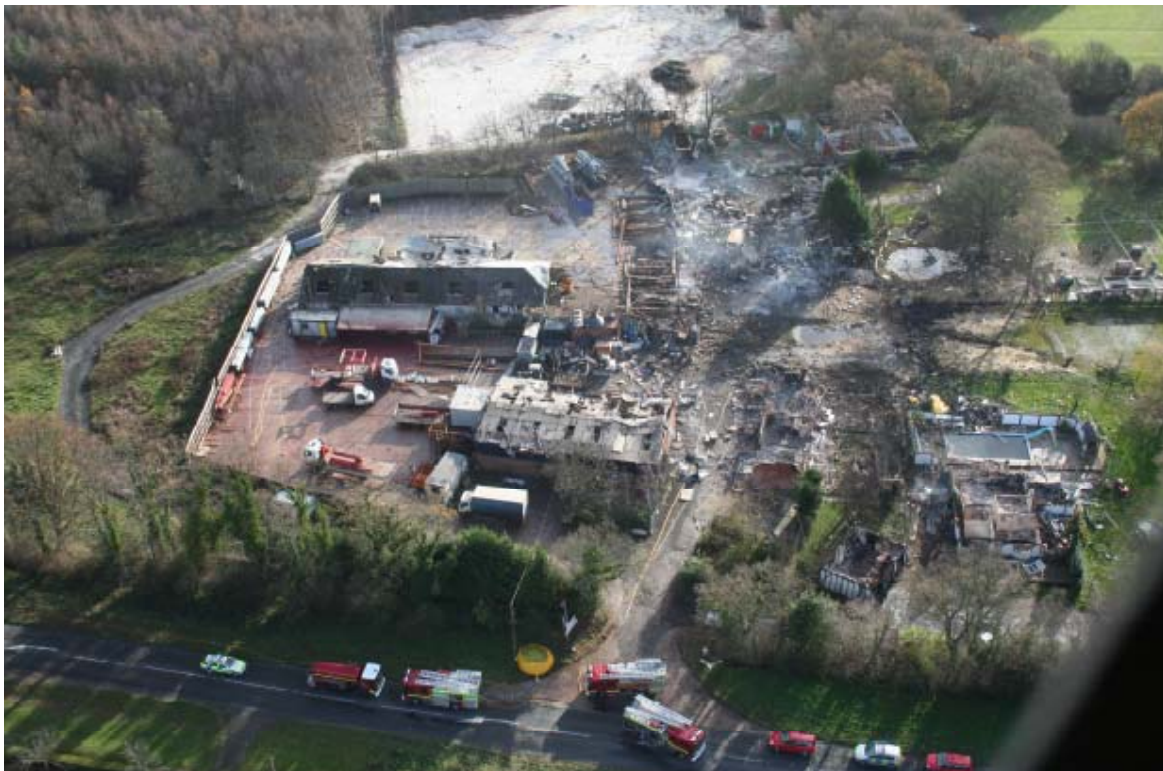
Photograph of site taken on Monday 4 December 2006

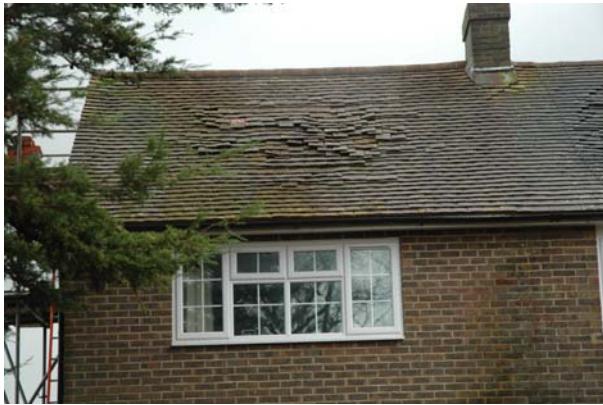
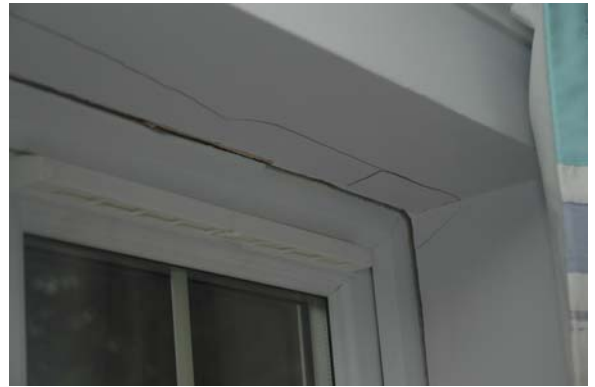
House 130 metres away from container

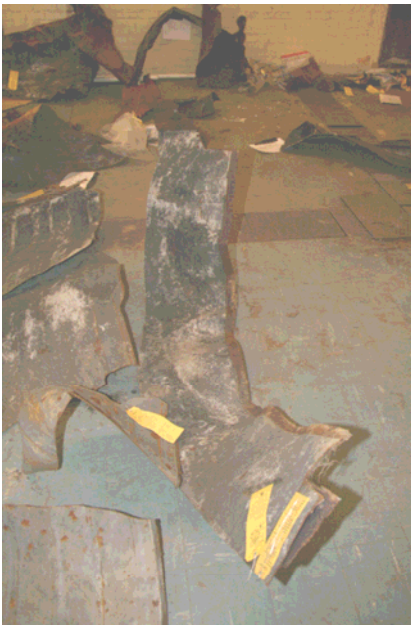
Section of ISO roof in caravan park 270 meters away

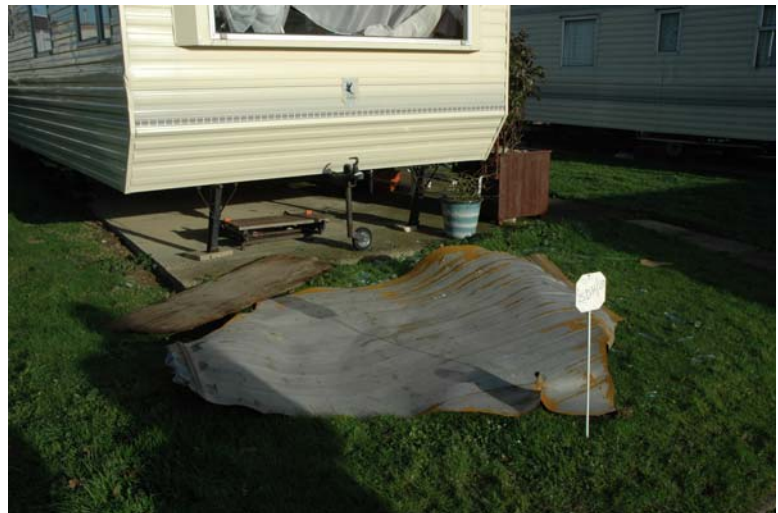
Section of ISO roof recovered 310 metres away from its original position.

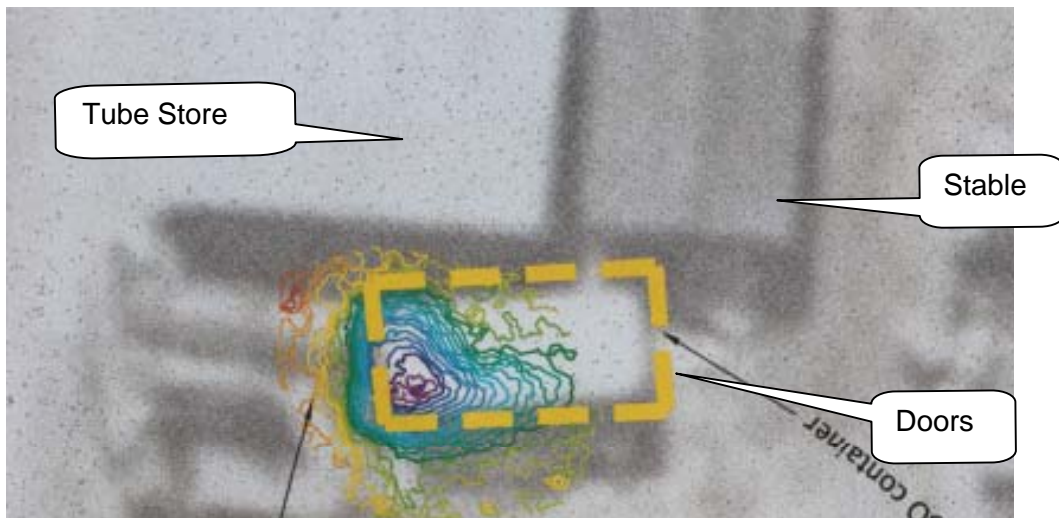
A crater in the area where the ISO container had stood was formed as a result of the explosion. Subsequent examination of the crater showed that the centre of the explosion was to the rear of the ISO container on the left hand side as viewed from the doors. The crater was approximately 6.3 metres long and 5.2 metres wide and just over 1 metre in depth. It had a volume of approximately 9.5 cubic meters. Following the explosion a LASER scan of the site was carried out and the results of this scan were overlaid onto an aerial photograph of the area. This shows the position of crater and contours of depth in relation to the ISO container.

Scan image showing the position of the crater and contours in relation to the container.

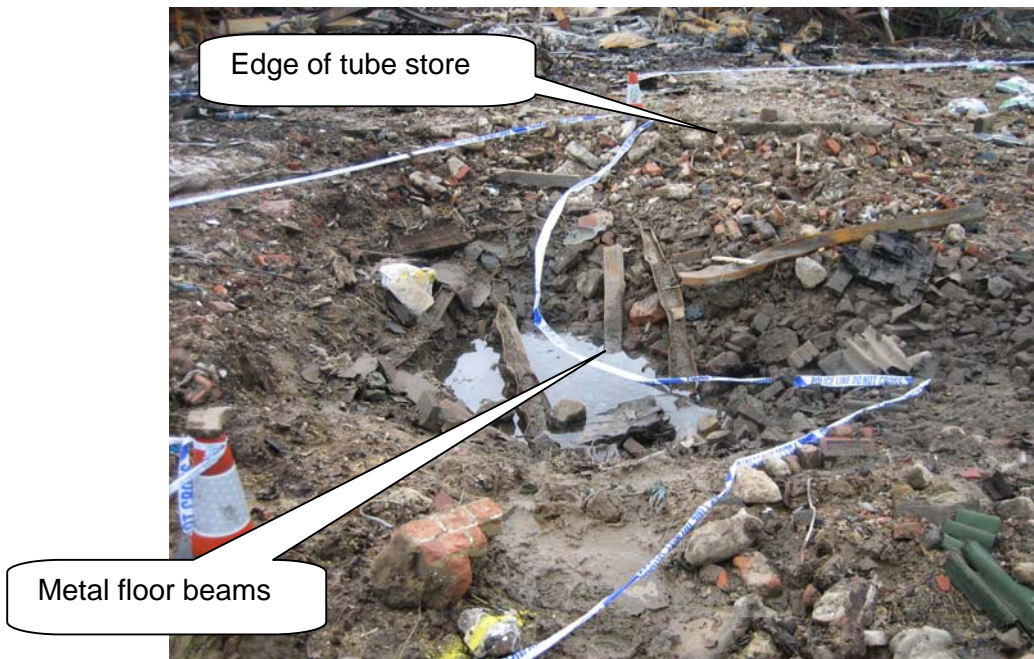
View of crater looking south-east

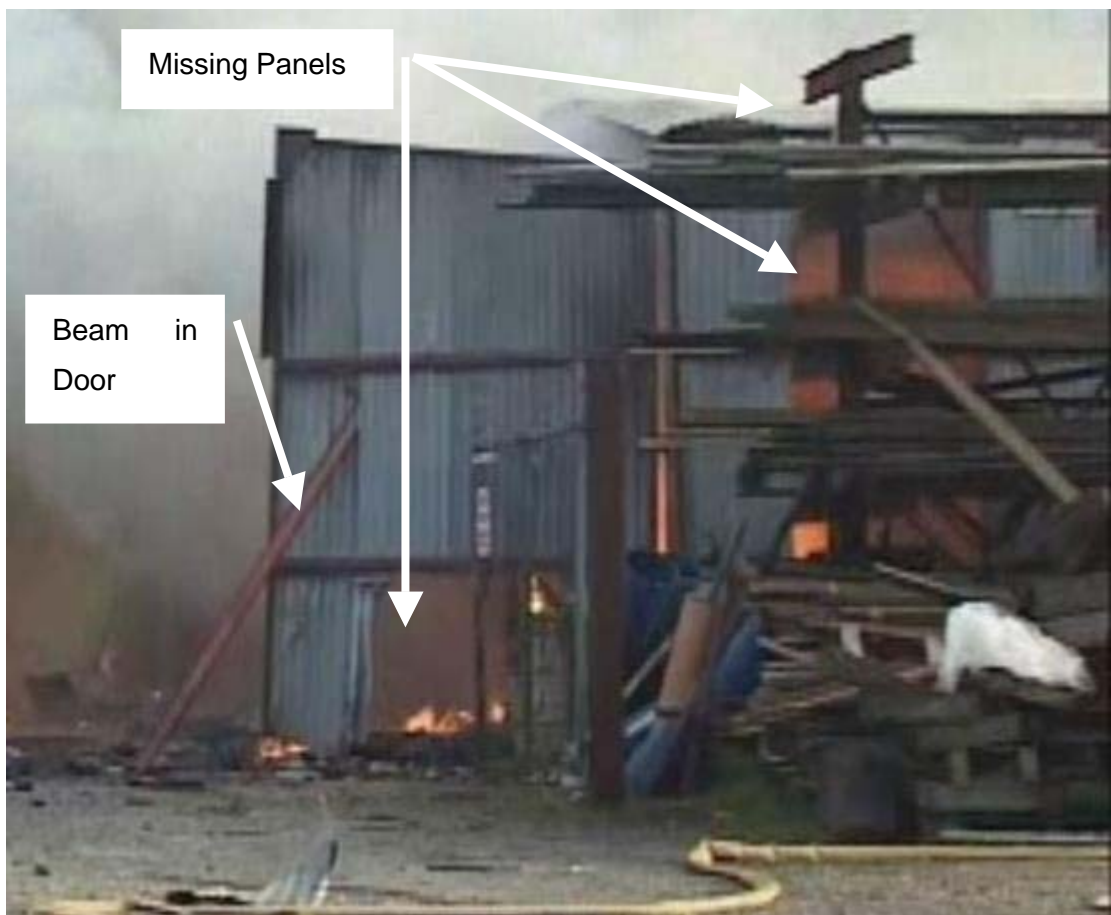
Examination of the video footage taken later in the incident (14:20:50) shows the door to Tube Store 1 being open. No crews have stated that they opened these doors and in fact the image shows substantial damage to Tube Store 1, with roof and side panels missing and also damage to the door itself, including a metal beam against or through the door. It is likely that this damage occurred during the initial explosion before the Service arrived.

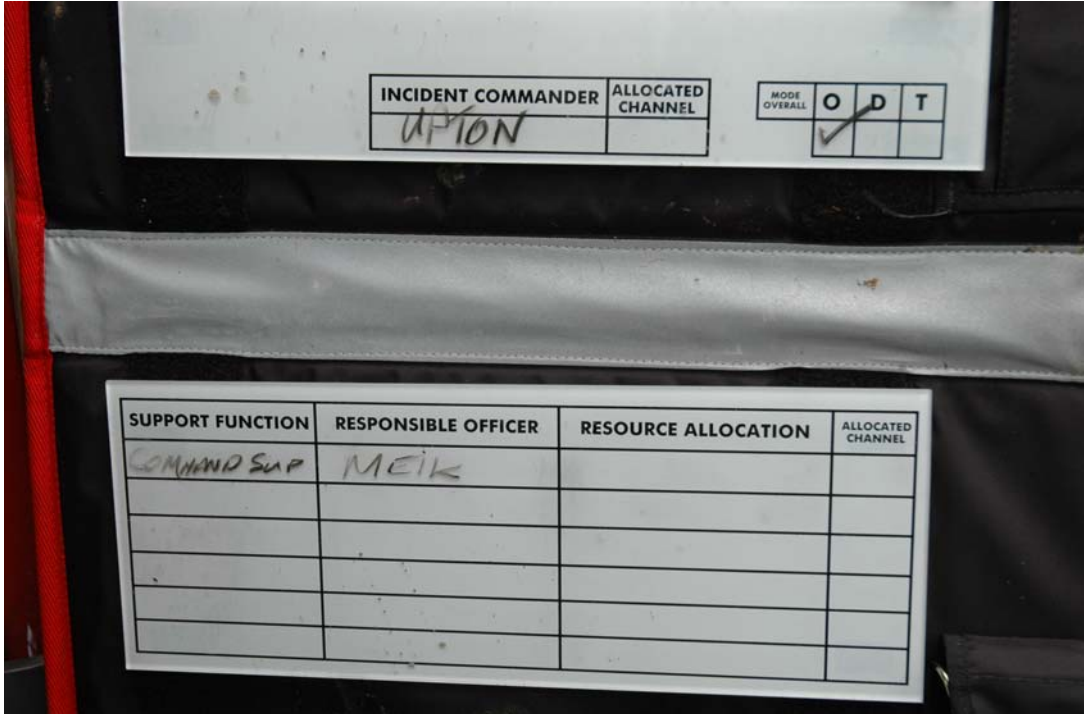
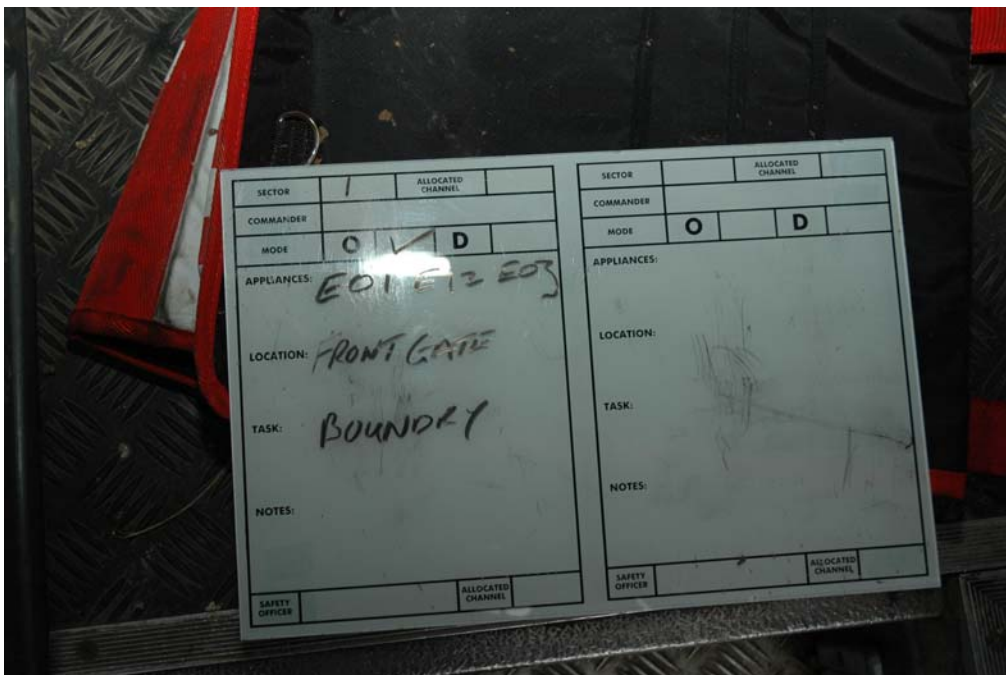
Photo of Command Support Board recovered post explosion

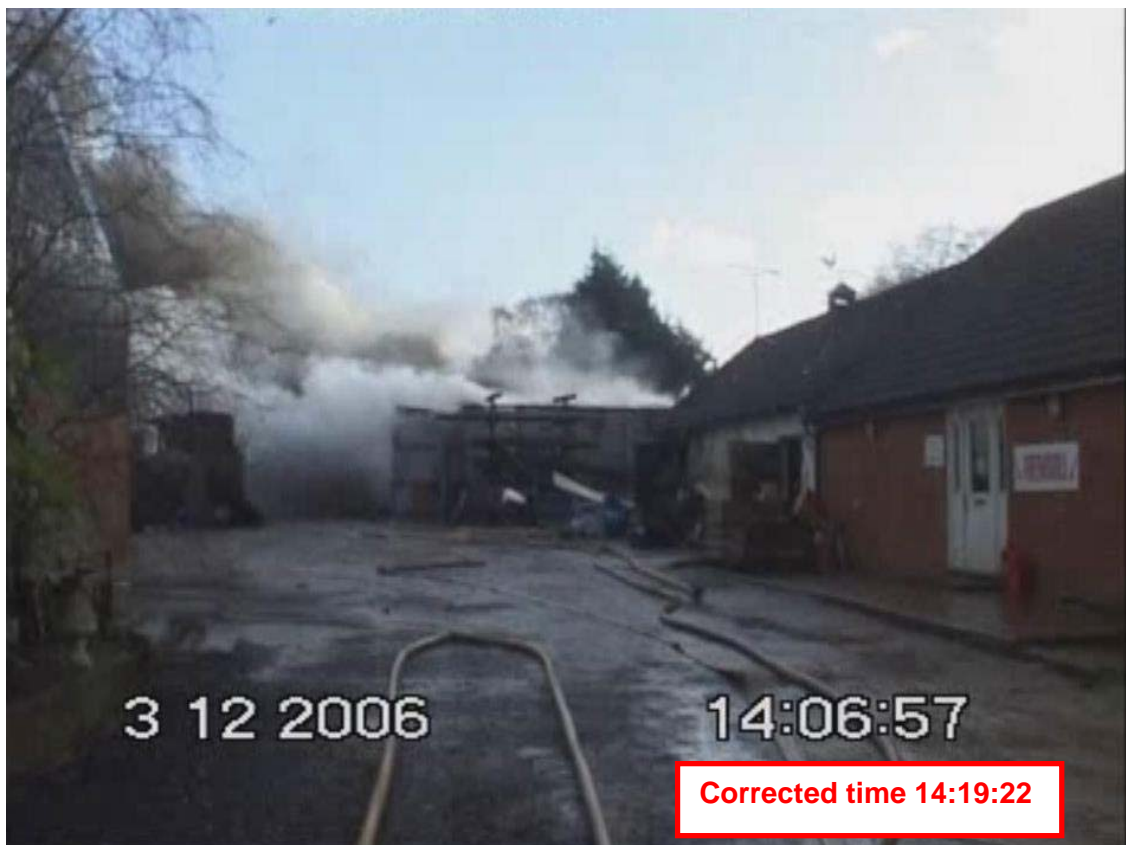
The video footage shows a developed fire within the area of the Box Store and Tube Store 1, which consists of a steel framed structure, clad with corrugated sheeting. The wind and smoke direction is from west to east. White coloured smoke is issuing from Tube Store 1 with darker smoke in the background from the area of the Box Store. Tube Store 2 is obscured by smoke.

Fireworks/projectiles are issuing from the area of the Box Store and Tube Store 1. Regular detonations are audible.

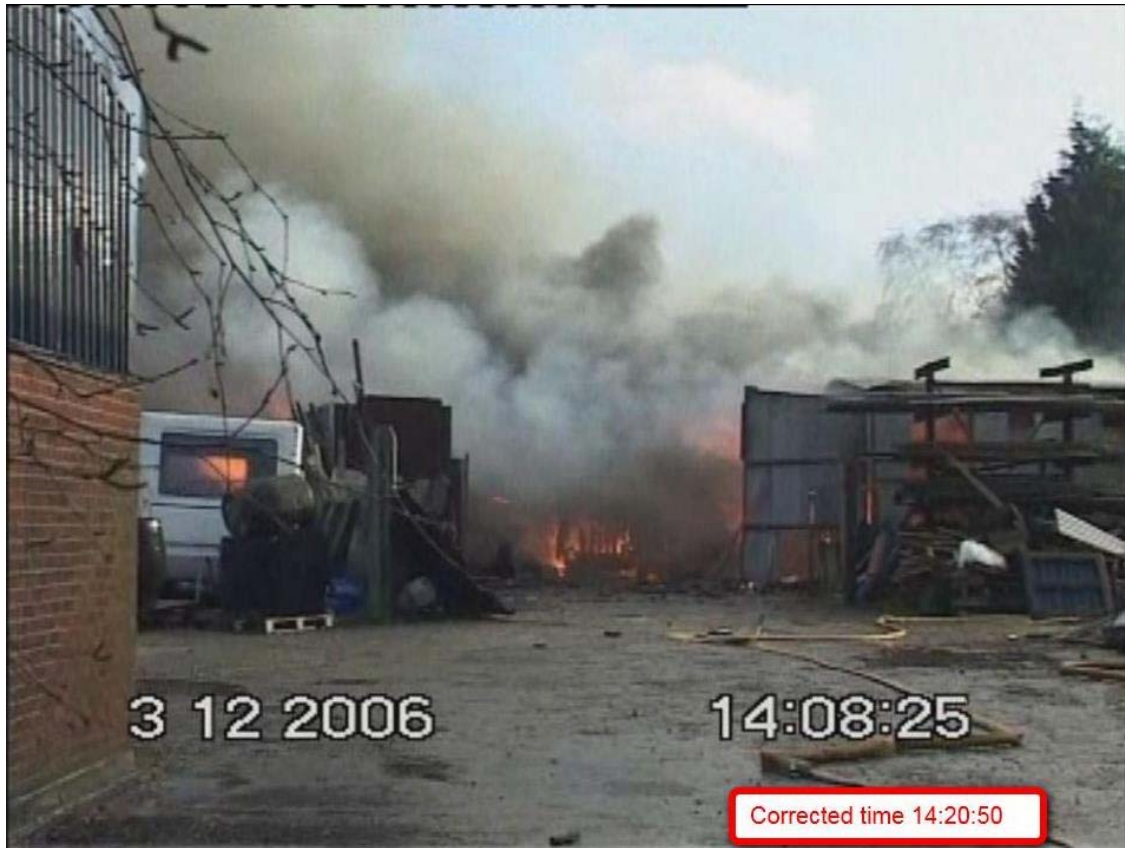
Footage shows the fire involving Tube Store 2 to the left of the main drive approaching a caravan located in the open area nearer to the site entrance. The van on the main drive appears to be severely damaged by fire. No firefighters are visible in this sequence. The video footage ceases at 14.21:44 hrs.

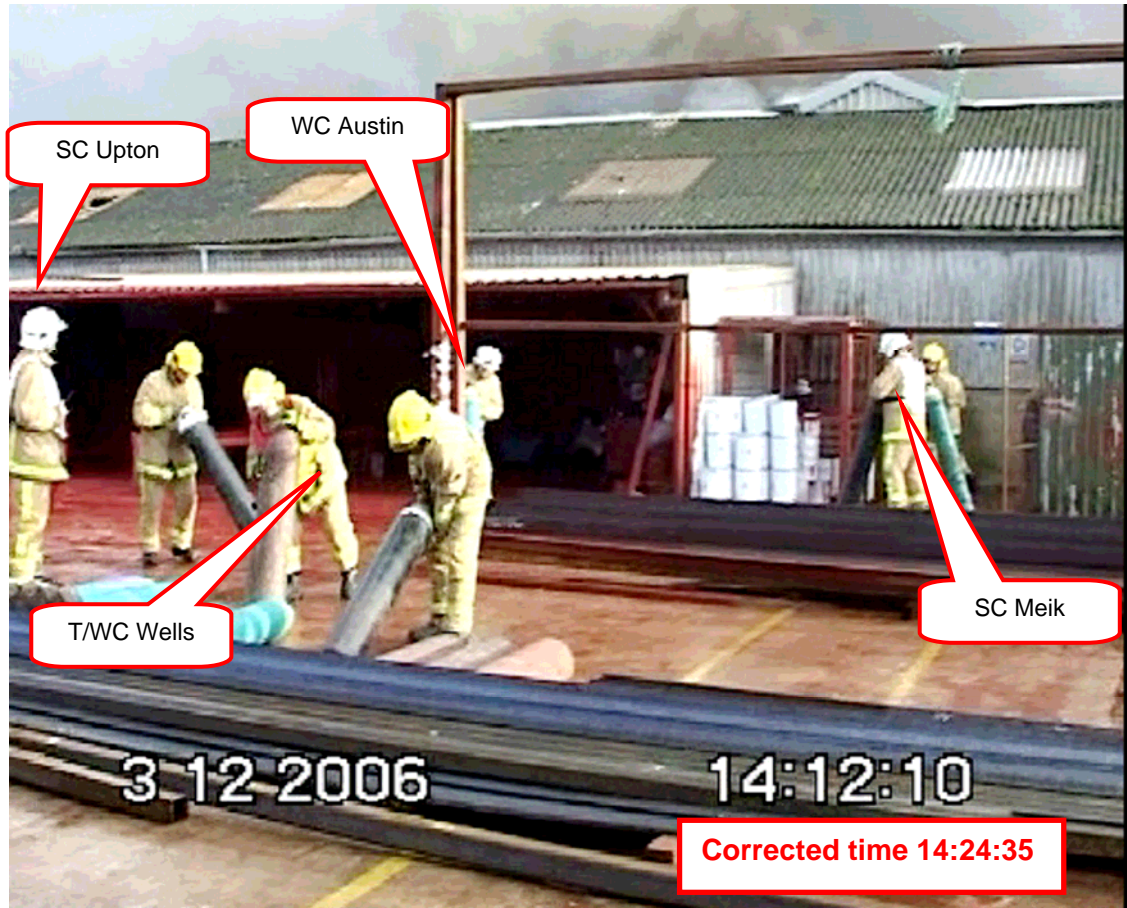
14.24:35

Video image of crews working in Sector 2 by Builders Beams 1

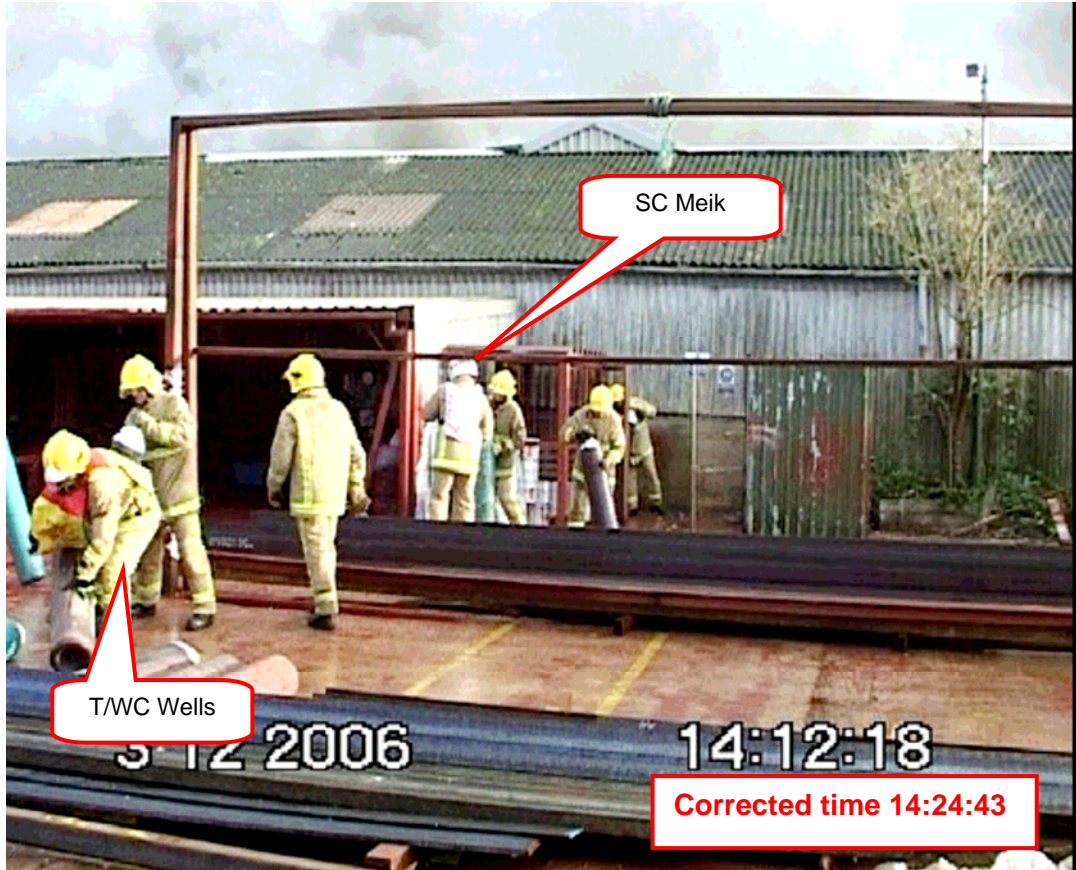
14.24:43

Video - showing SC Meik and crews continuing with the removal of the compressed gas cylinders from the caged store. T/SC Upton is no longer visible

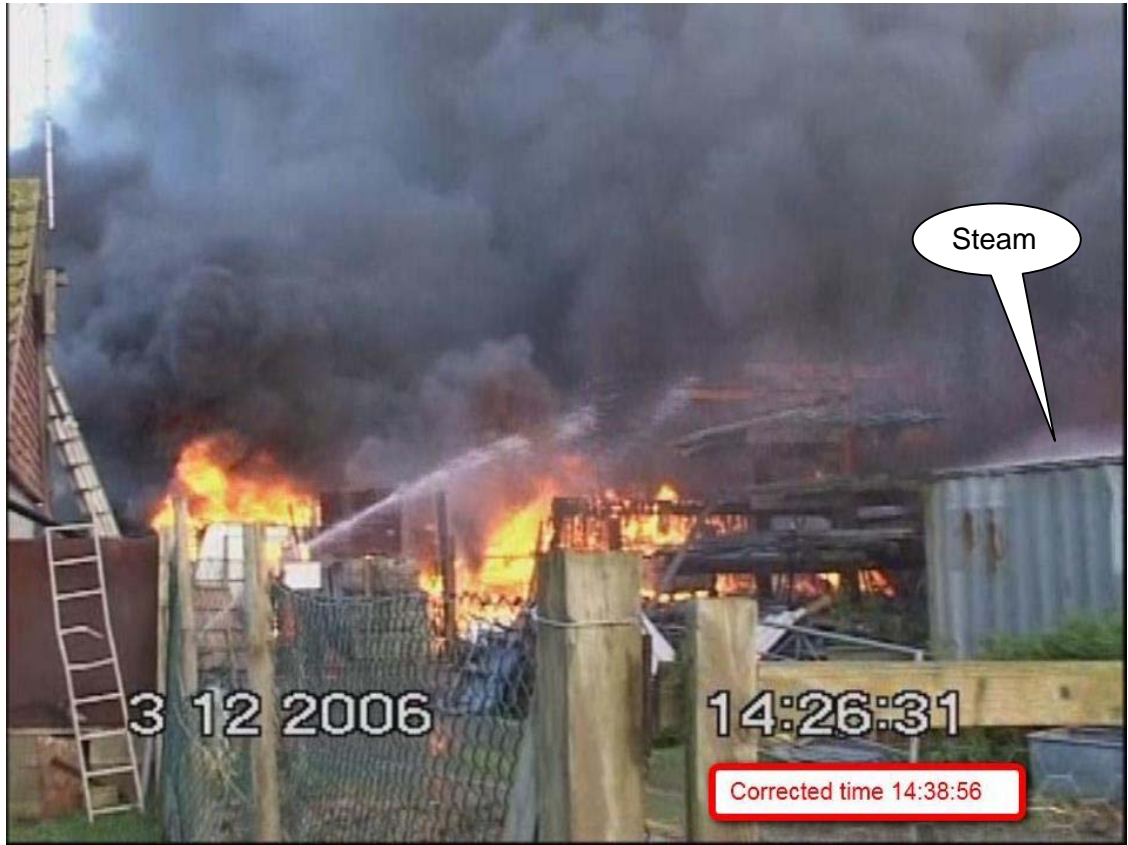
**14.38:56**

Momentary surges of water from one of the monitors in the main drive briefly strikes the top of the north-east corner of the ISO container. Steam is then visible coming from the top of the container.

The fact that the water hitting the top of the container is turning to steam indicates that the metal container is being heated by direct flame impingement and/or radiated heat.

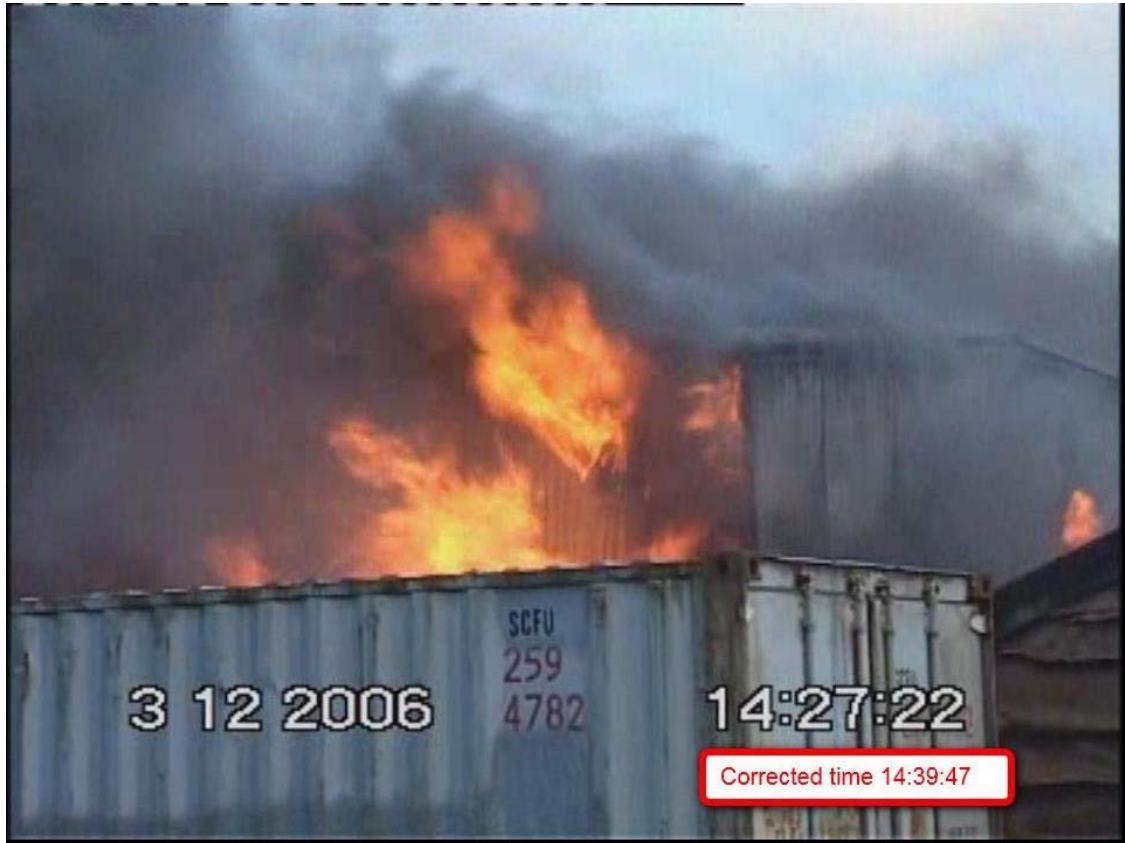
Fire is seen emerging from the north end of Tube Store 1, and appears to be directly impinging onto the south-east side of the ISO container.

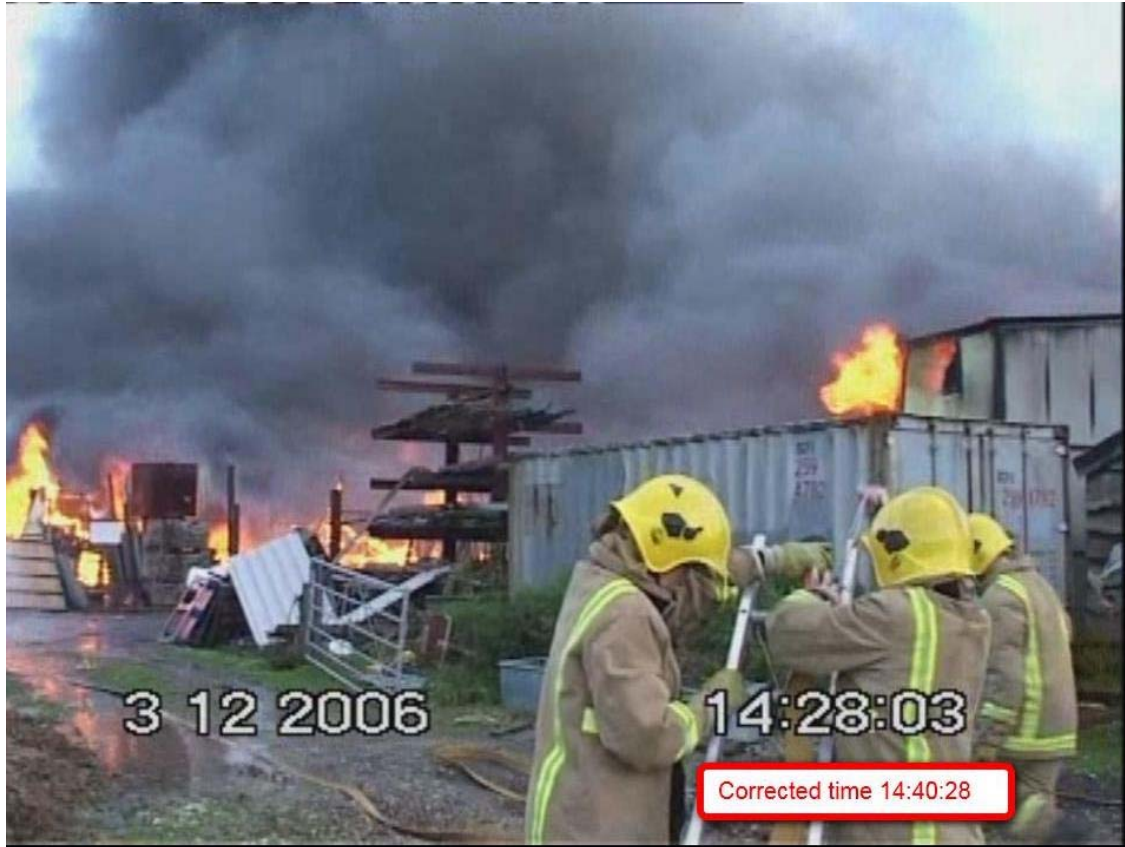
14.40:28

The construction of improvised monitor 3 is being completed by Ff Wood, who is assisted by Ff Skeffington. This comprised of a hose line and 'Unifire' hand controlled branch tied to a section of ladder, which is braced against a pallet of paving stones.

Ff Skeffington is wearing firefighting gloves, but the front flap of her tunic is not secured. Ff Skeffington's hair is visible between her tunic collar and helmet indicating that her fire hood is not being worn raised over her head. Ff Wood is not wearing gloves. Neither appear to be using their helmet face shields or goggles.

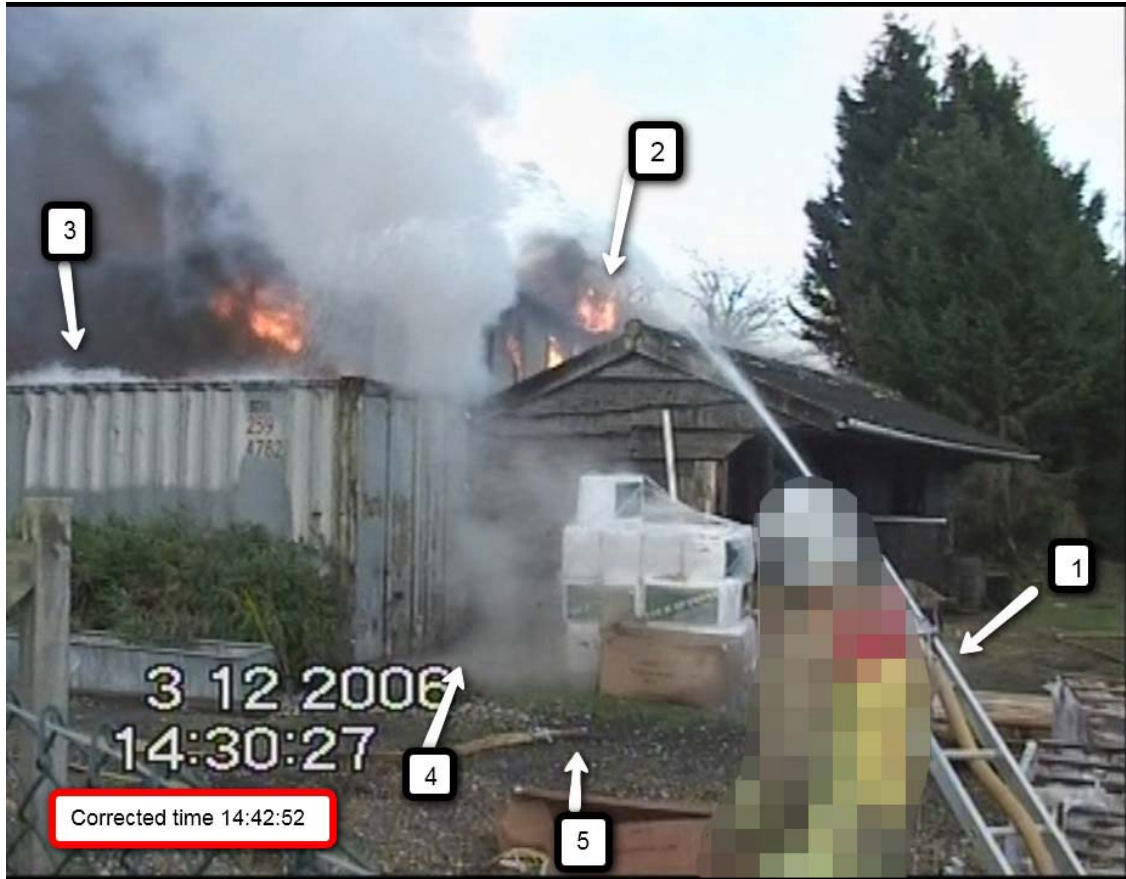
14.42:52

1. Monitor 3 is charged with water and is producing a continuous jet, which appears to strike the south-west area of the ISO container roof;
2. Small fires are venting at high level along the roof of Tube Store 1 and the box store;
3. Steam or smoke is visible along the roof of the ISO container;
4. White smoke is coming out of the container along the base and top of the doors and,
5. An uncharged line of delivery hose is lying on the ground by the stack of bales. A hand-controlled branch appears to be inserted into the female coupling.

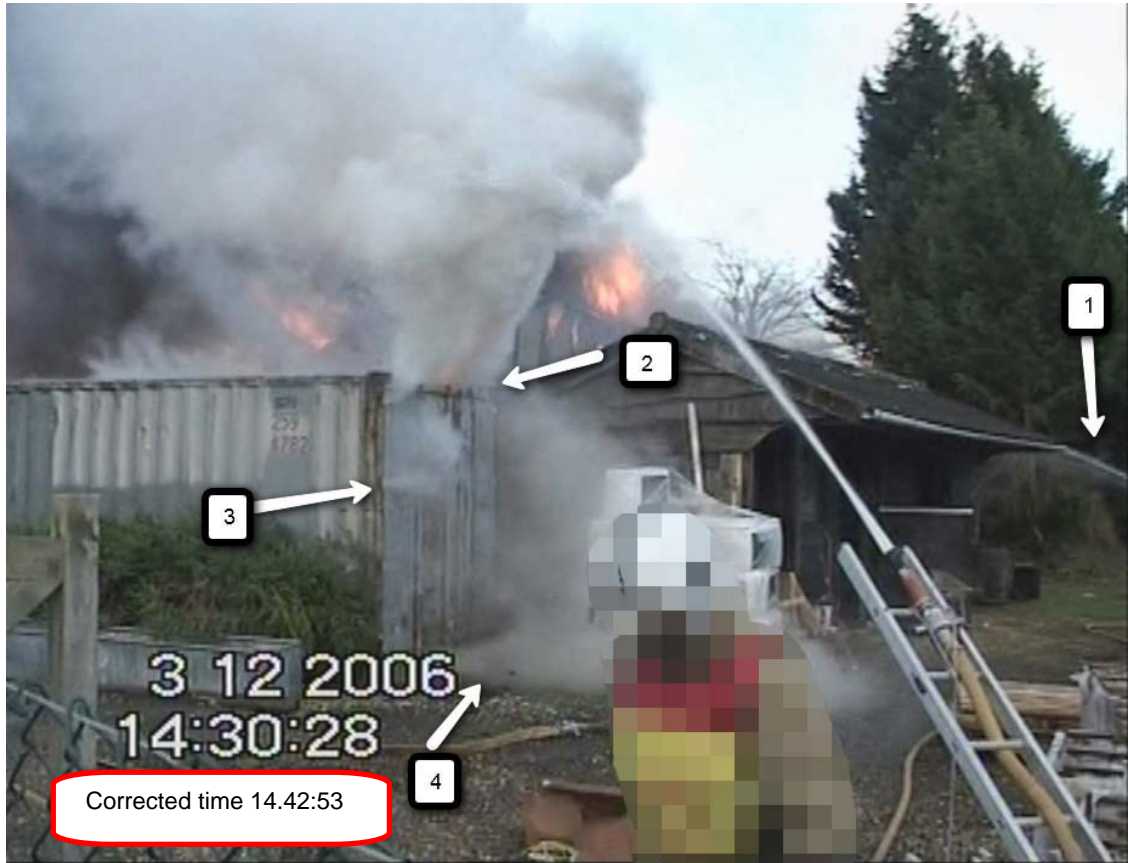
14.42:53

1. A jet of water is seen just appearing from the right hand side of the image, the source of this water is not seen but is consistent with coming from monitor 4;
2. White smoke or fumes are visible at high levels around the door frame on the ISO container with a small flame or orange coloured smoke visible at the centre top of the doors to the ISO container;
3. Smoke is also coming from around the edge of the doors by the hinges and,
4. Smoke appears to be coming out under pressure at the bottom of the doors of the ISO container as small items of debris appear to be disturbed.

The disturbance of debris from around the vicinity of the ISO container doors indicates the possibility of increased pressure within the container.

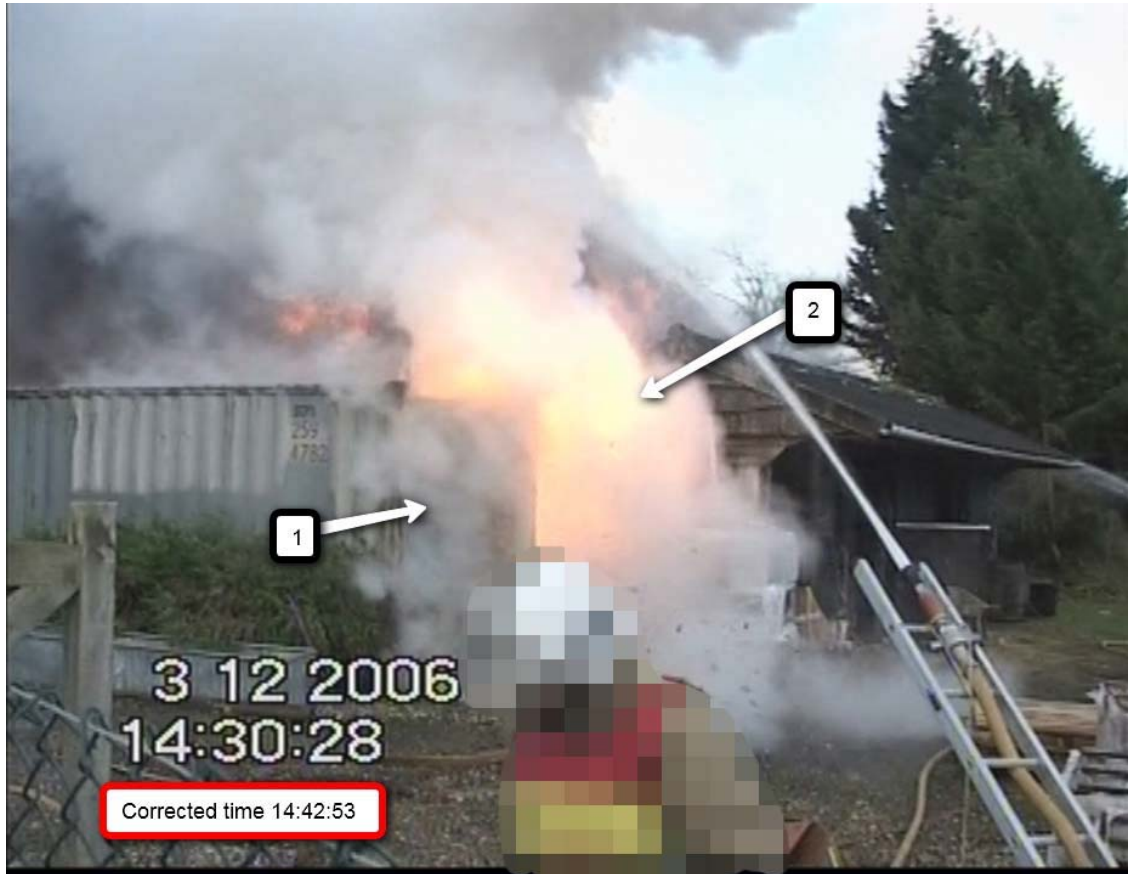
14.42:53

1. The door on the ISO container nearest the camera is shown to be open at approximately right angles to the container. It is possible that the door furthest away from the camera is also open, but this is partially obscured by:
2. Orange-coloured smoke or a large flame rapidly emerging toward the stack of bales in front of the stable. A rapid increase in noise is audible.

The rapid propagation of flame or smoke appears to originate from within the ISO container, which indicates that a deflagration is occurring.

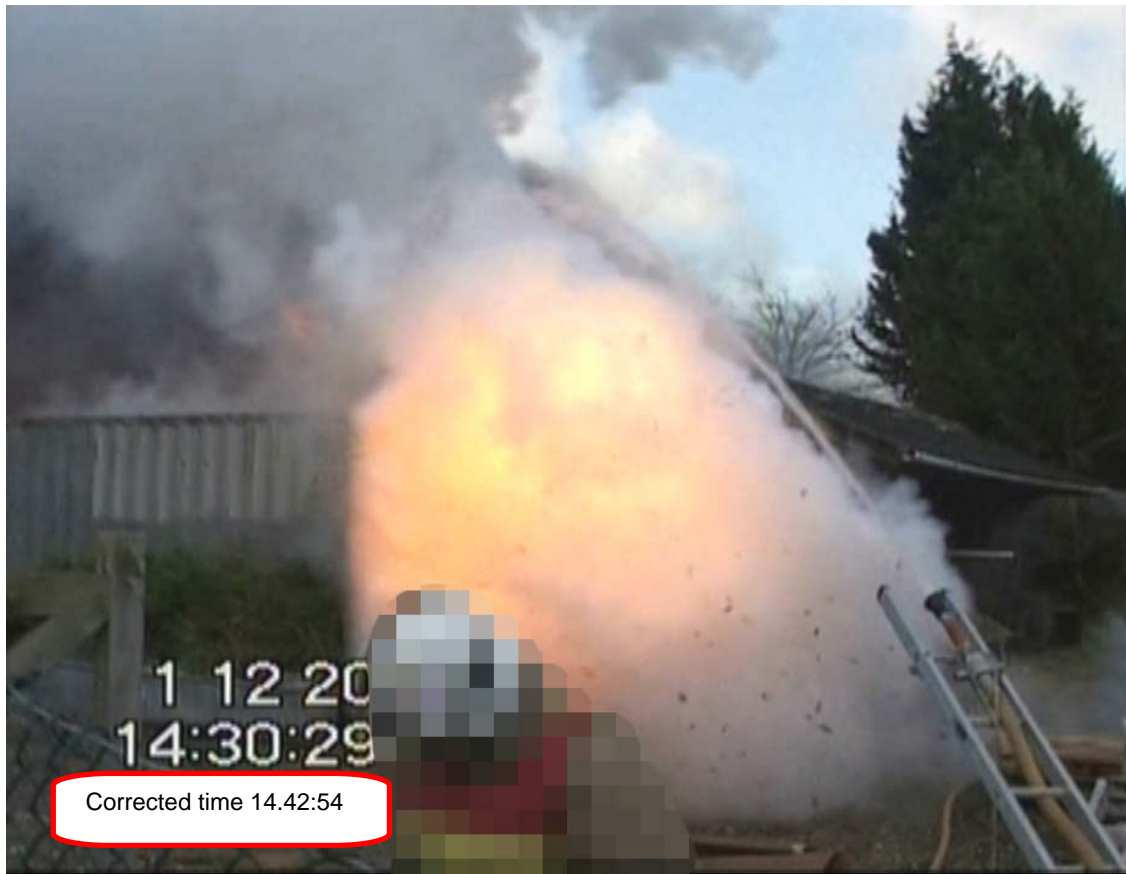
The jet from monitor 3 is still directed toward the roof of the ISO container. However the impact point from the jet is now obscured by a cloud of smoke and/or steam, with a considerable amount of debris picked up by the jet of smoke. The camera image remains steady

It is likely that the end of the video coincides with the contents of the ISO container moving from deflagration to detonation and rupture of the steel container within the next second. This detonation is the main explosion as described by various witnesses.

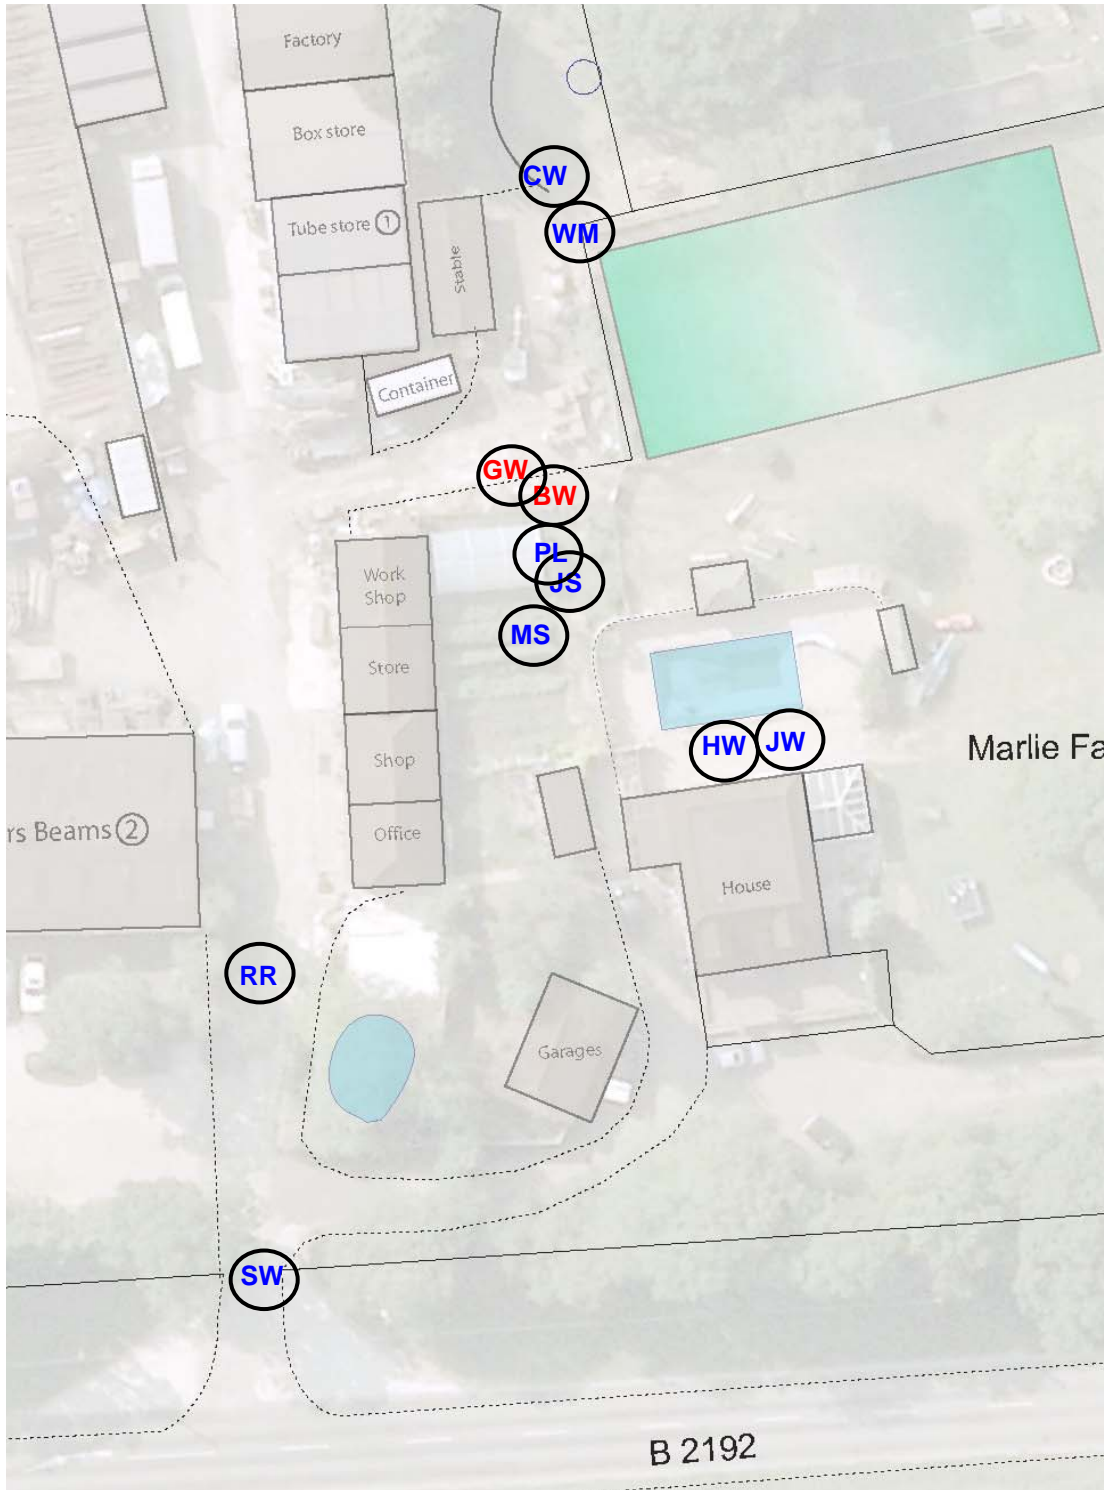
Plan showing location of casualties at the time of explosion.
