# **The Marlie Farm Explosion**

**Significant Findings of the Investigation into the  
Fire and Fatal Explosion  
Festival Fireworks Ltd, Marlie Farm, Ringmer, East Sussex, U.K.  
Sunday 3 December 2006**

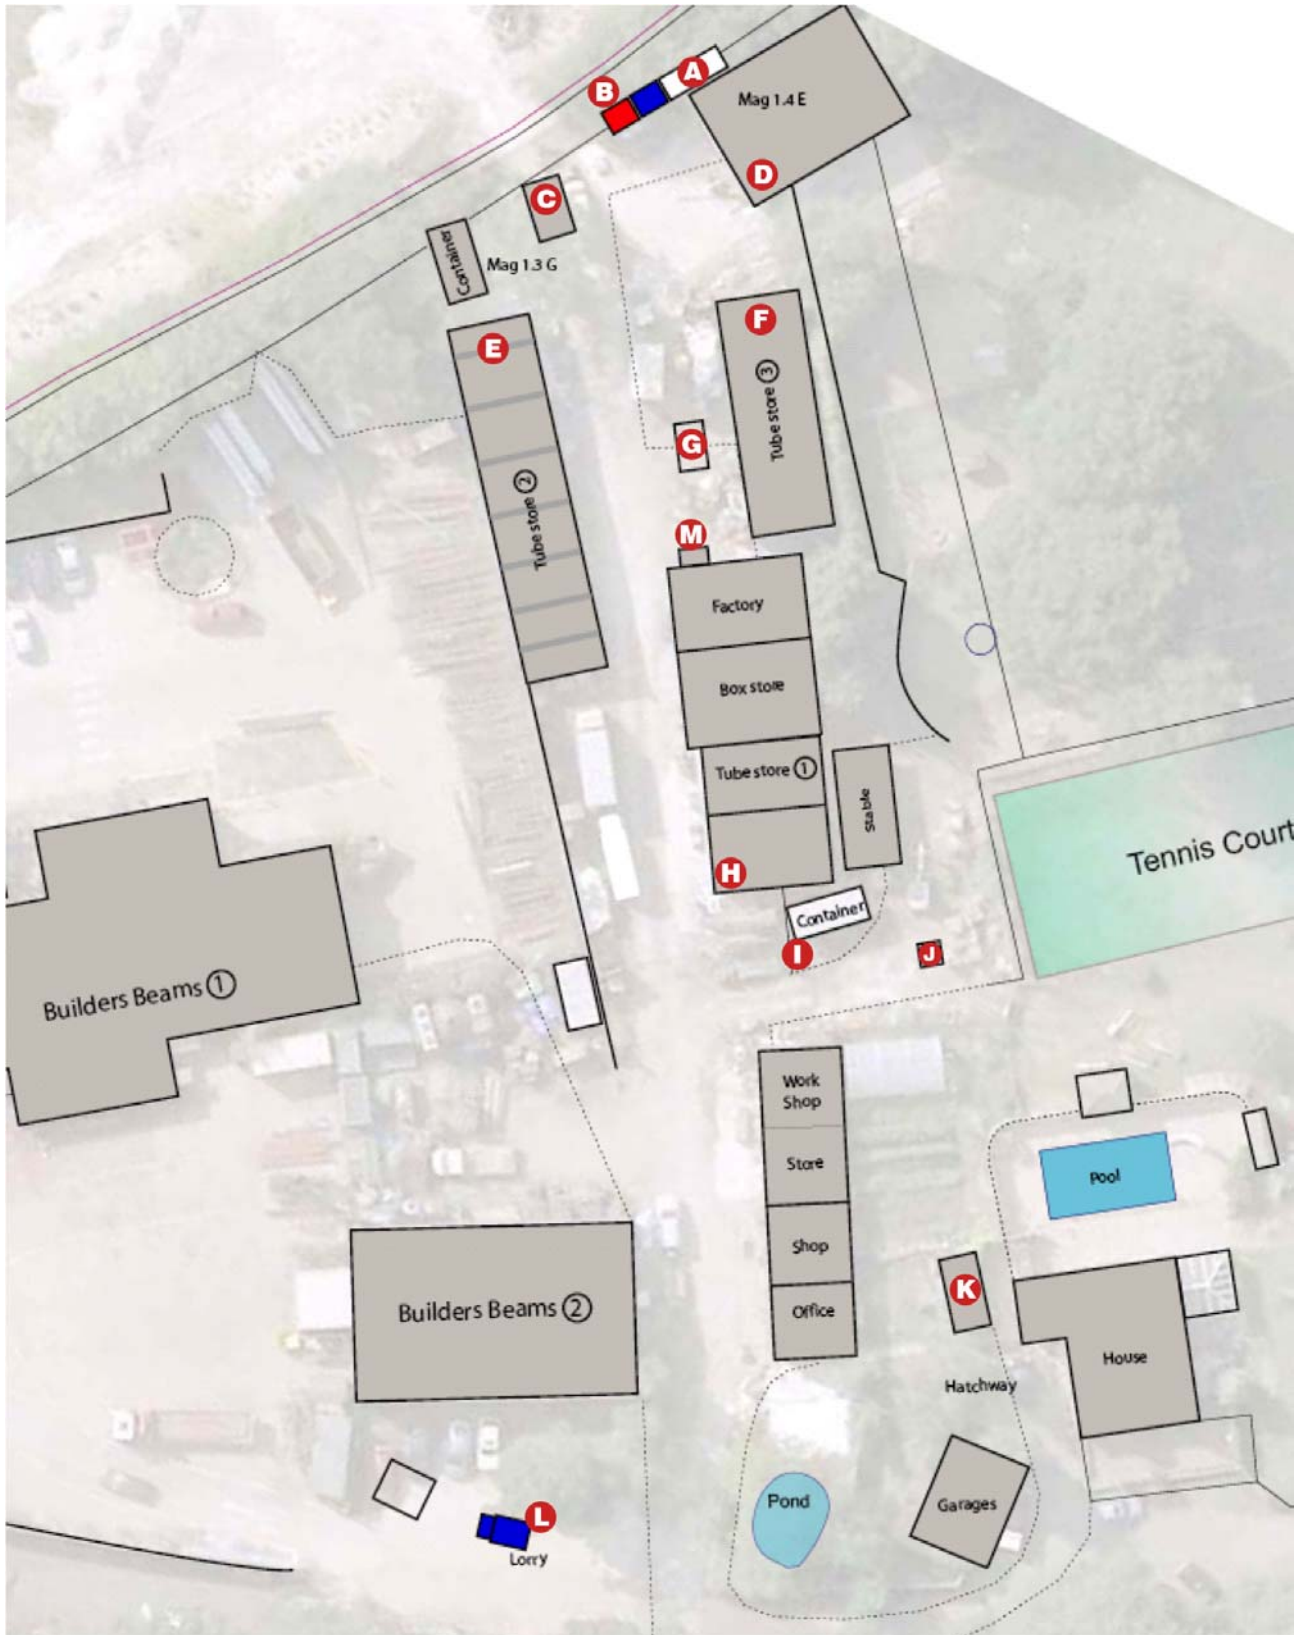
Plan showing location where fireworks found during the site investigation  
(Locations A-M.)

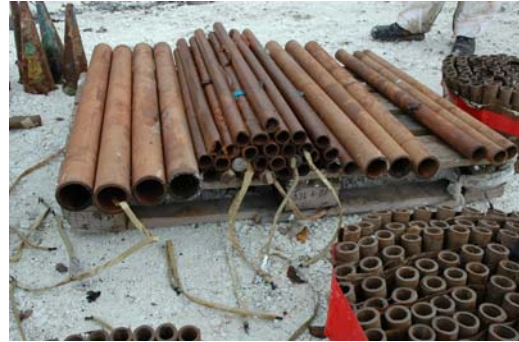
Fireworks after being removed from bucket, note fuses still attached

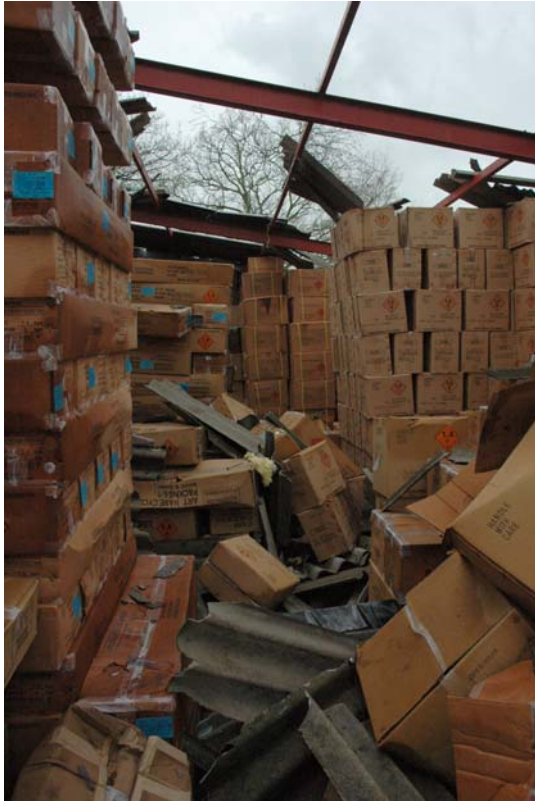
Cartons of fireworks in magazine E

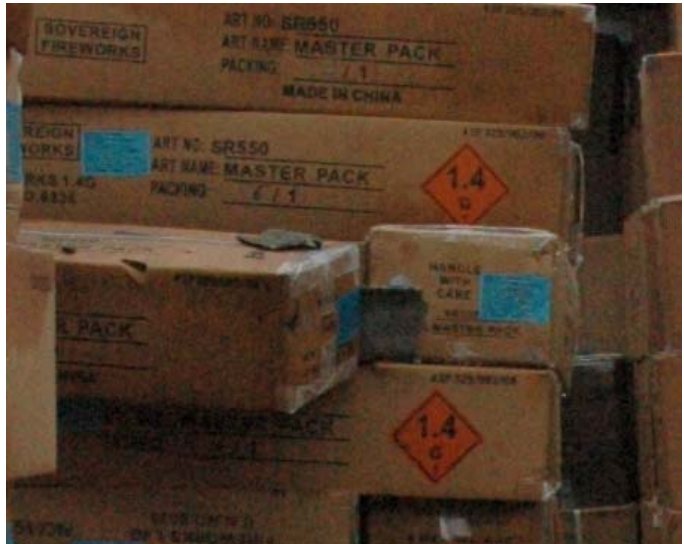
Master Pack rockets labelled as 1.4 but had been reclassified under the default scheme of 2003 as 1.1

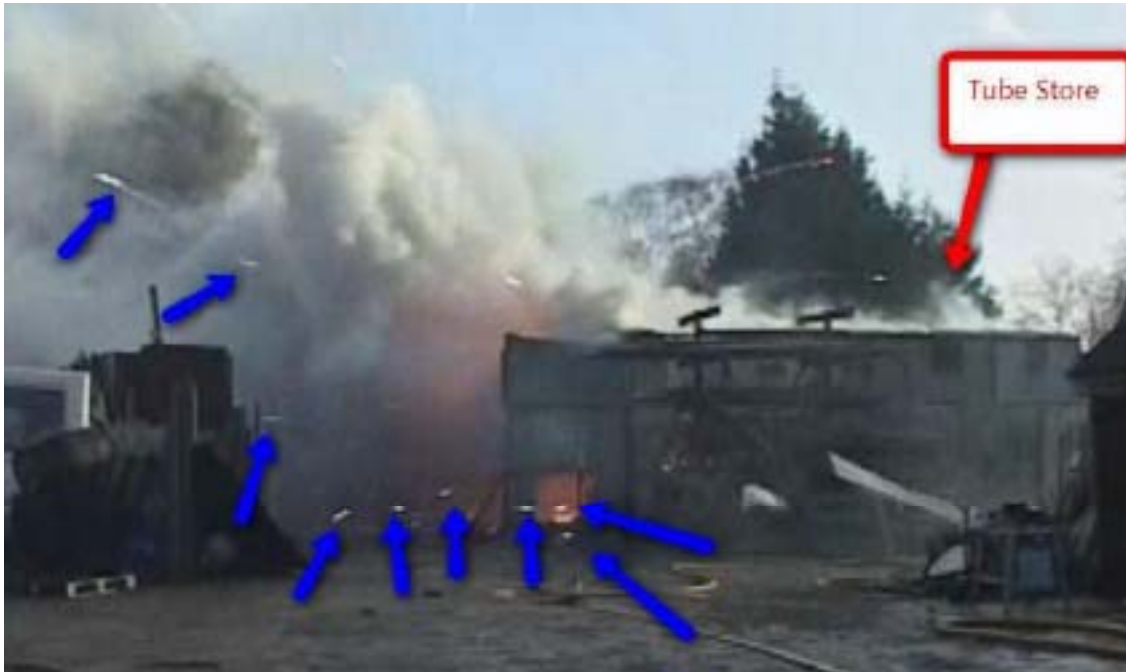
### Location H – Tube Store 1

Tube Store 1, which was not shown as the same size and location on the HSE licence, was for the storage of non-explosive and non-hazardous materials only. Evidence from video footage of the incident taken by Brian Wembridge shows fireworks activating from Tube Store 1.

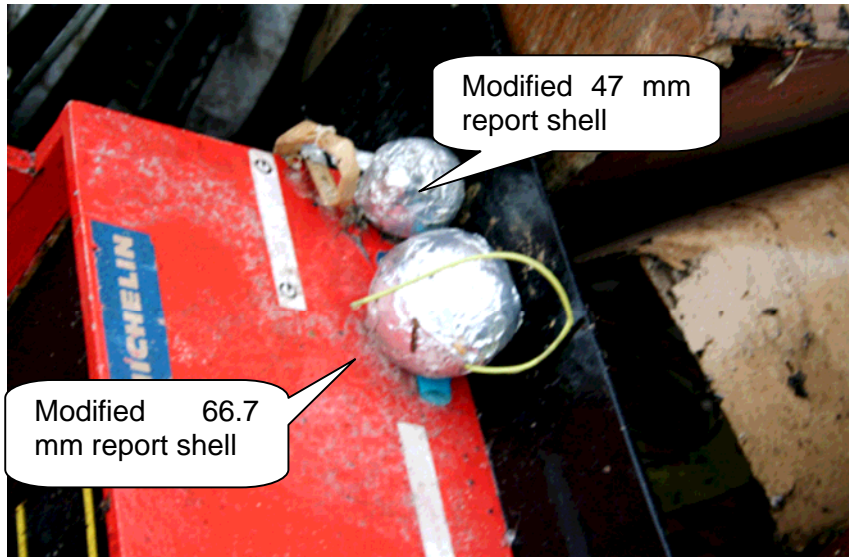
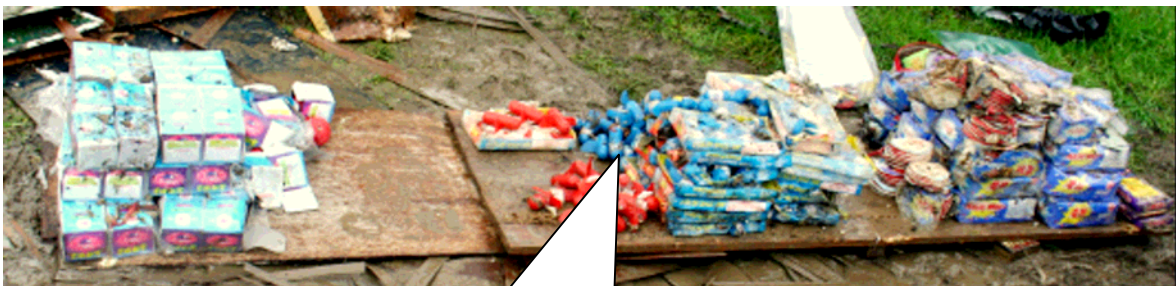
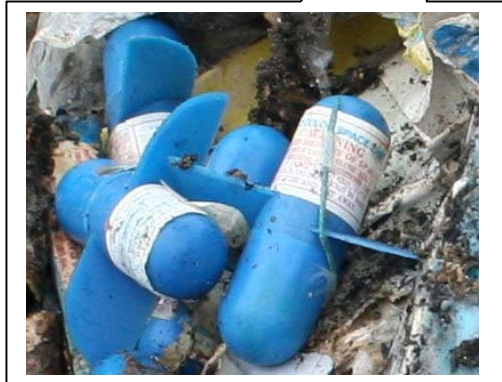
### Location K – Hatchery

This was in an area outside of the HSE licensed area. Inside the building, four modified 66.7 mm report shells, two 47 mm modified report shells, “hundreds” of two different types of spinners (not illegal to possess but prohibited for retail sale) and titanium salute shells with lift charge removed, were found.

Image above shows fireworks found in the hatchery with close up of spinners.

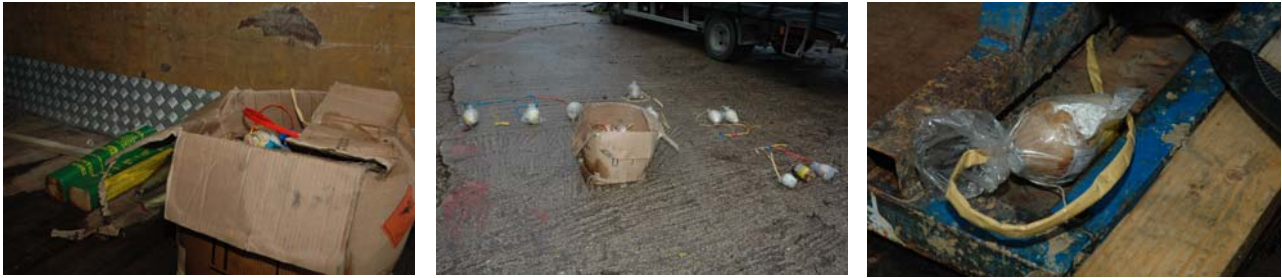
### Location L – Curtain Sided Lorry

The Curtain Sided Lorry is known to have returned from a display on the previous Friday. It had been parked within the main site operated by Festival Fireworks and was moved to the location next to Builders Beams once the fire started but before the arrival of the Fire & Rescue Service. One 65 mm report shell (HD1.1) and a number of other fused fireworks were found on the lorry.

Fireworks found in curtain sided lorry

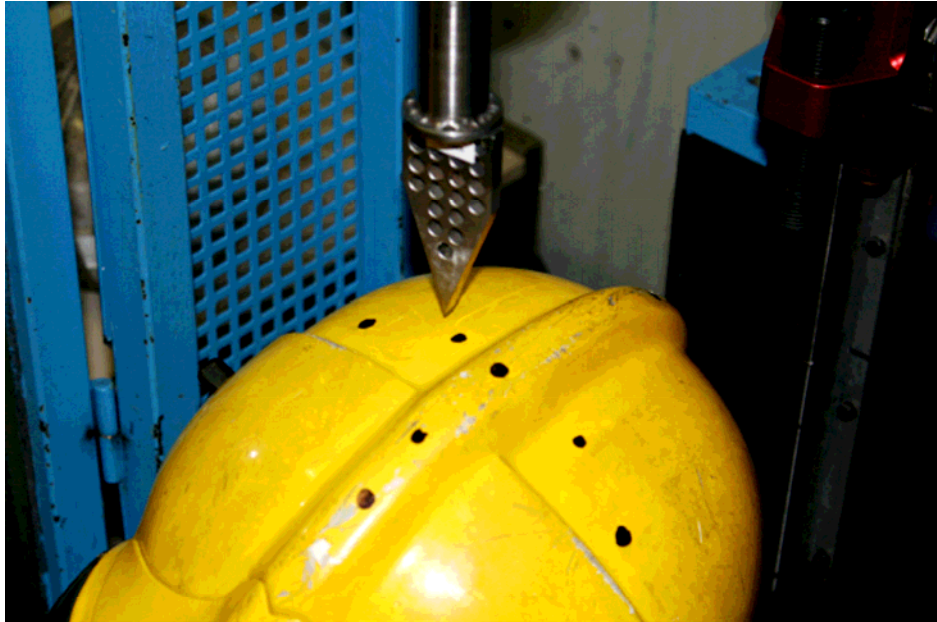
Impact testing of Gallet F1S/F1A helmet

The Gallet F1 fire helmet was required by the EN standard (in place in 2006) to detach from the wearer when subjected to a pre-determined pressure/force, in order to prevent neck injuries. The evidence indicates that the helmets tested performed to the required specification in this respect.

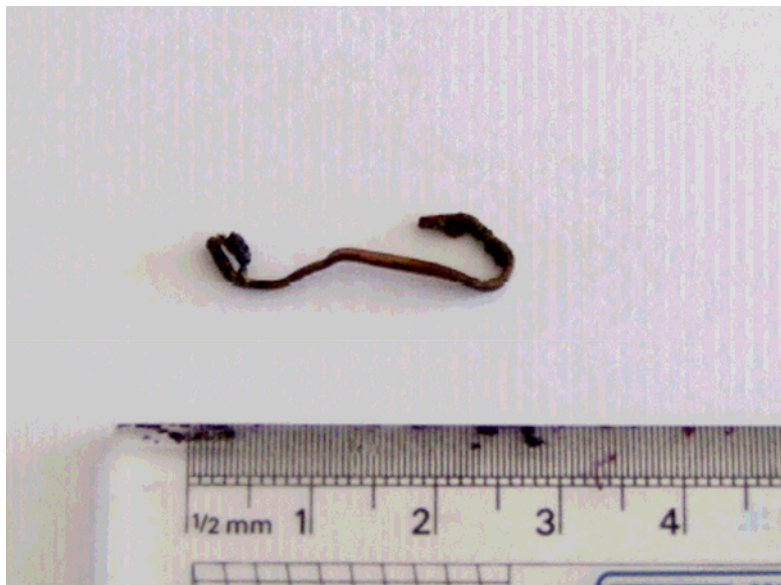
In addition, other PPE - including gloves, boots, over-trousers and tunics - worn by firefighters who were in close proximity to the explosion also sustained damage, for example penetration by projectiles.

Metal fragment that penetrated overtrouser and subsequently removed from Firefighter's thigh in Hospital

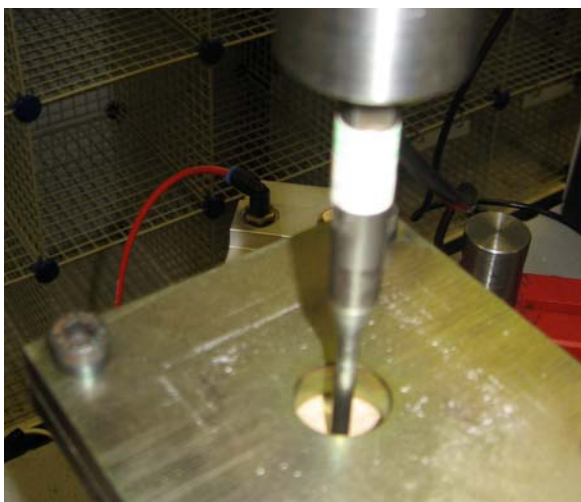
Puncture resistance test

Evidence indicates that the trousers and tunics performed to specification, the penetration and/or

damage to the garments was as a result of them being subject to forces outside the design limitation of the EN Standard.

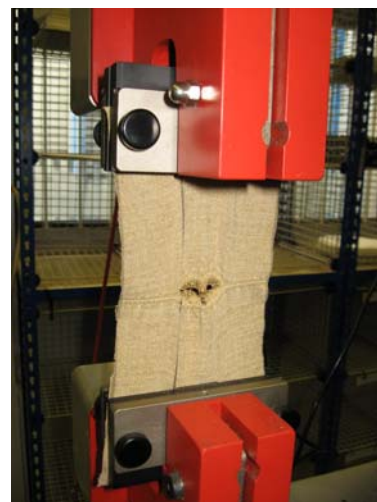
Grab Tensile test

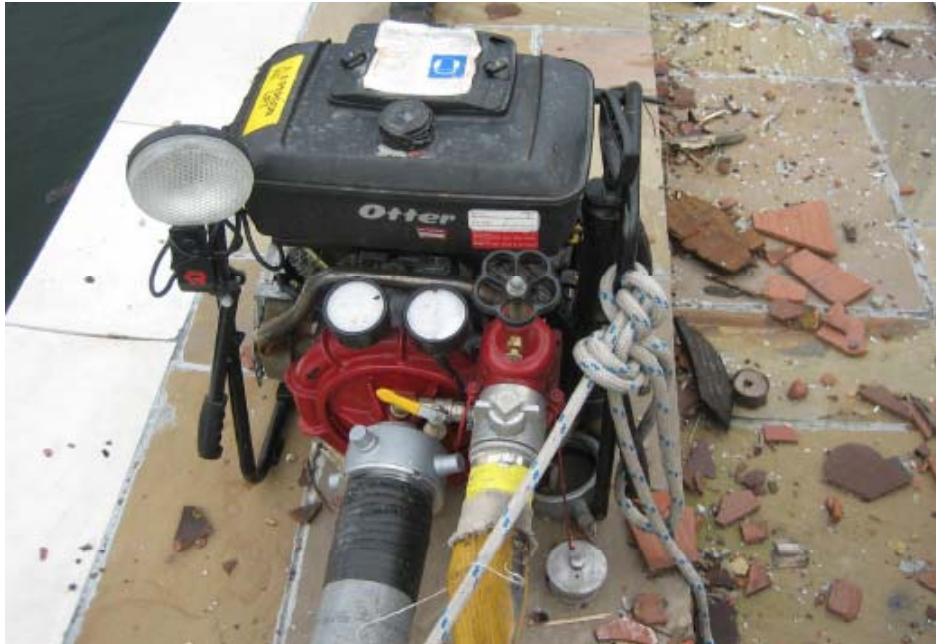
The Otter pump remained in situ at Marlie Farm during the police forensic investigation and was subsequently impounded by the AI team and placed in secure storage. The pump was subjected to a safety inspection at the Service workshops. This identified that the pump had sustained damage from radiated heat. The pump started successfully, was allowed to run for a short period, then primed from an open water supply and delivered a single main jet. It was considered sufficiently serviceable to enable more thorough testing.

The light portable pump in situ at Marlie Farm on 15 December 2006

The pump was subsequently taken to a fire appliance manufacturer's site, where full vacuum and output tests were completed using their deep lift facility and hydraulic test rig. Tests verified that the pump could maintain a maximum output of 1,000 litres per minute at one-bar pressure and up to 810 litres per minute at four bars.

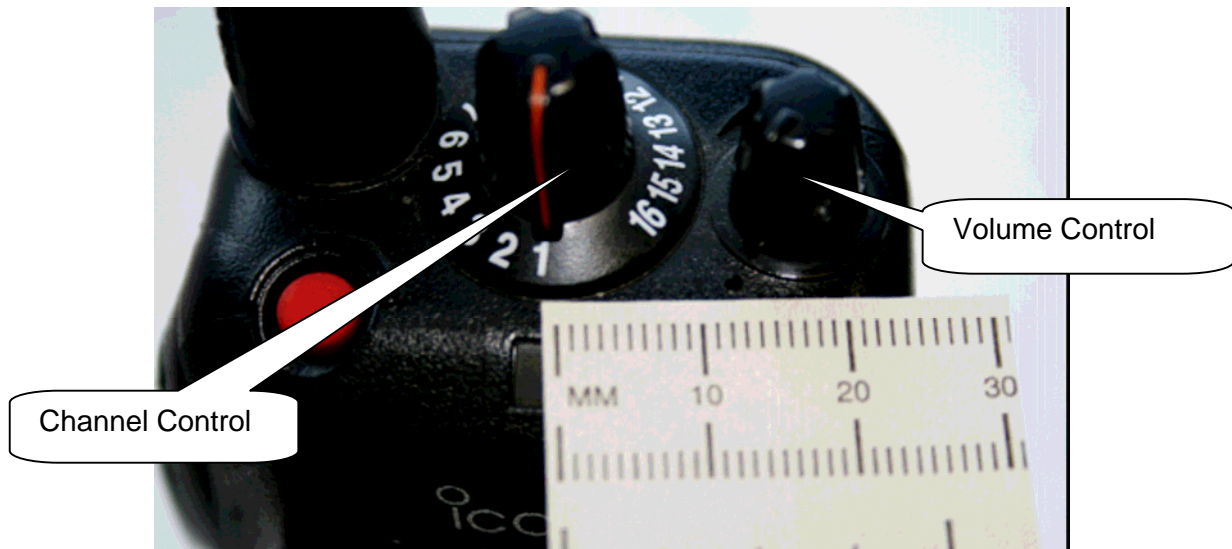
The fireground radio used by Watch Commander Wicker was an ICOM 1C F41GS handheld radio. When channel 1 is selected (normal fireground communication channel), the position indicator on the rotary channel selector is at its closest proximity to the rotary volume switch and the distance between the channel selector and the volume switch is less than 1 cm.

It is possible to inadvertently change channels on the ICOM 1C F41GS due to the close proximity between the channel selector and volume control. In order to prevent inadvertent changing of radio channels these radios have a facility to electronically 'lock' a selected channel.

Image showing an Icom fireground radio. Note the close proximity between the channel selector and volume control.
